**Subject:** **Park Avenue Barge Engineering Concept Development Report**

**HIGHLAND PARK  
PARK AVENUE BARGE ENGINEERING**

**Concept Development**  
**FINAL DRAFT**

**October 5, 2018**  
Rev 2

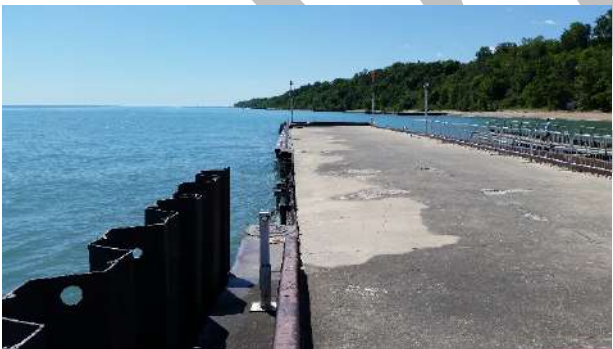
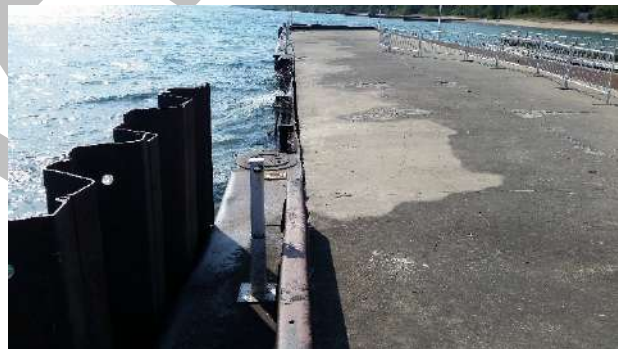
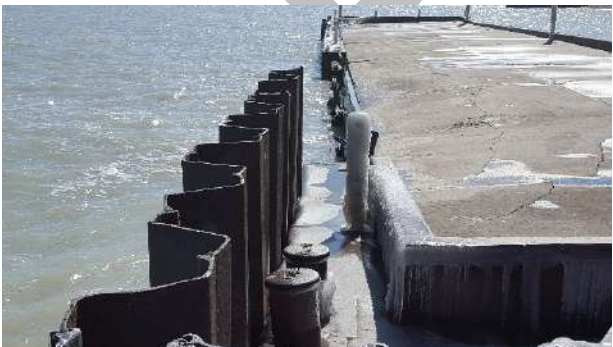
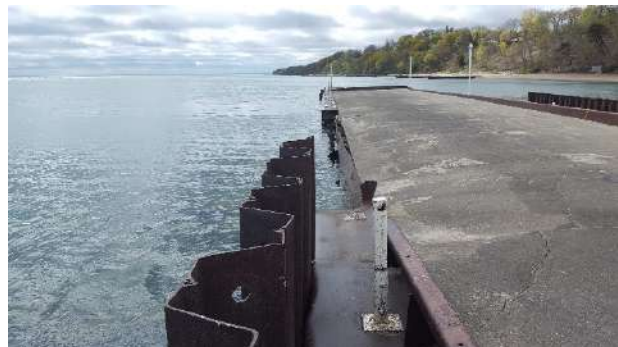
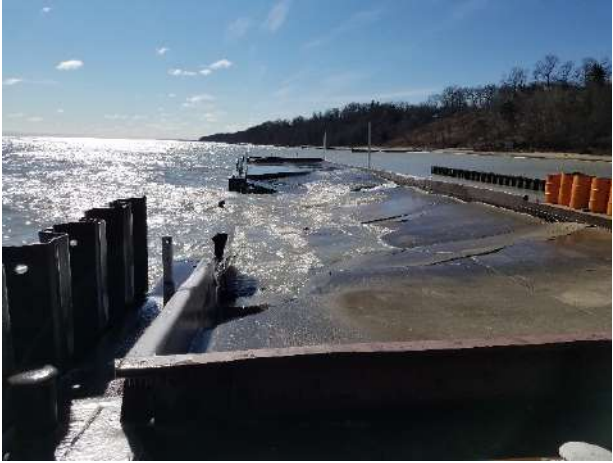
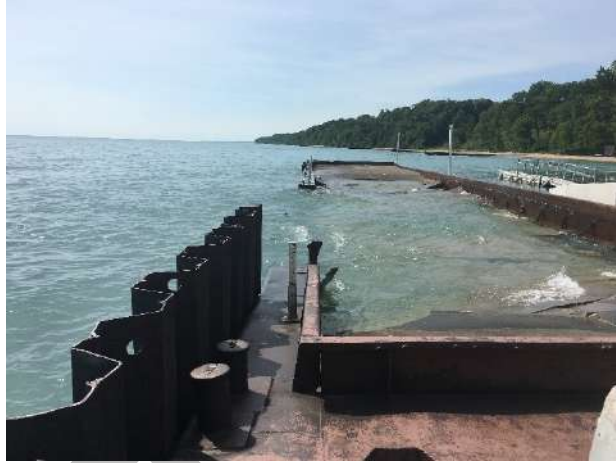
Figure 1 Timeline Inspection Photos, at North End of Barge Looking South

The Park District of Highland Park owns and maintains the barge. Concerns were raised about its structural integrity in 2015 when large cracks started to appear in the concrete deck and over 60 feet of the outer hull of the steel cargo box ripped away, exposing damaged steel cables and support frames. Damage to these members significantly reduced the lateral support of the structure. Access to the barge was thereafter limited and the condition of the structure was assessed yearly by W-T Group, LLC through March 2018. Continued concrete cracking and separation from the steel cargo box were observed over this time until the steel side plates along the lakeside of the barge collapsed during the winter of 2017-2018, resulting in the collapse of the concrete deck and waves entering into the barge. The barge continued to deteriorate as waves worked to remove the fill material. Photos of the deterioration of the lakeside wall of the steel cargo box can be seen in Figure 1 below.

The combined weight of the concrete slab, snow, and ice could not be suspended by the wire ropes once the fill had leached out of the cargo box. This led to the catastrophic failure over the 2017-2018 winter period. Wave events have continued to remove the remaining fill, extending the reaction to either side of the opening in the barge and the continued failure of the concrete slab can be seen in the final two pictures of Figure 1 taken only four months apart.

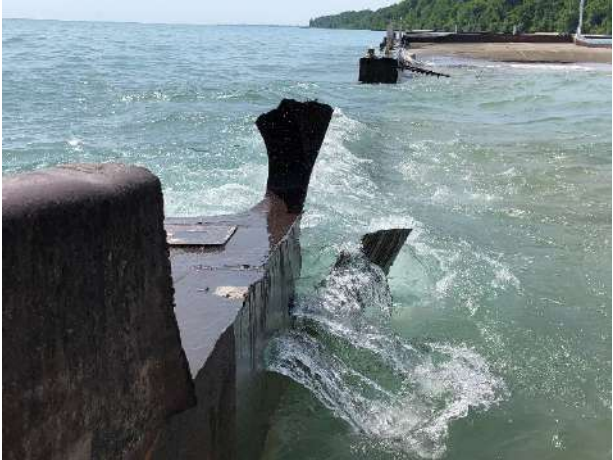
A selection of photos are shown below. The lakeside wall of the steel cargo box was found to be severely damaged between 0+23 and 0+88 and the remaining steel seen below the water surface was undergoing repeated flexing due to the passing wave energy. This was resulting in fatigue failure to the steel surrounding the opening in the cargo box lakeside wall. A significant portion of the concrete walking surface had collapsed into the vacant space where fill material had been pulled out of the box opening. The portion between approximately 0+10 through 1+30 was underwater and inaccessible. A number of cracks extending over the edge of the barge and extending into the water were observed. Those on the lakeside actively showed water entering and exiting with each passing wave.

A. Broken Cargo Box Wall

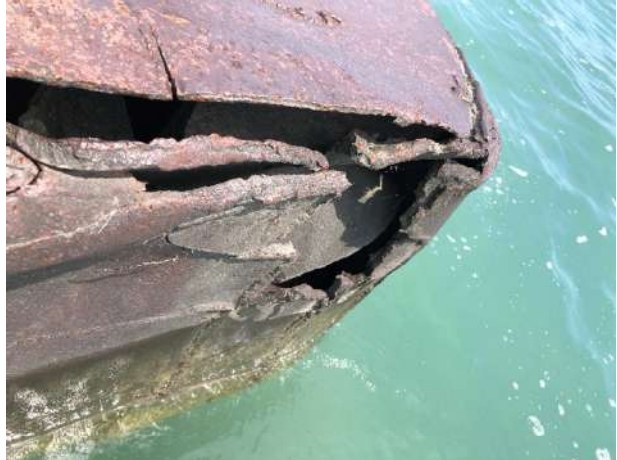
B. Damage to SE Outside Corner

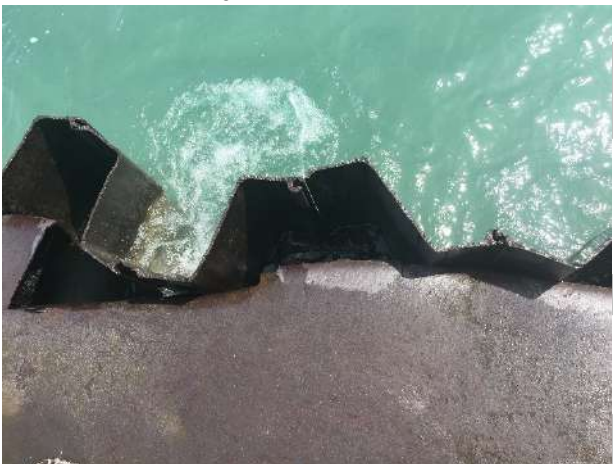
C. Bent/Broken Sheetpile Connections & Box

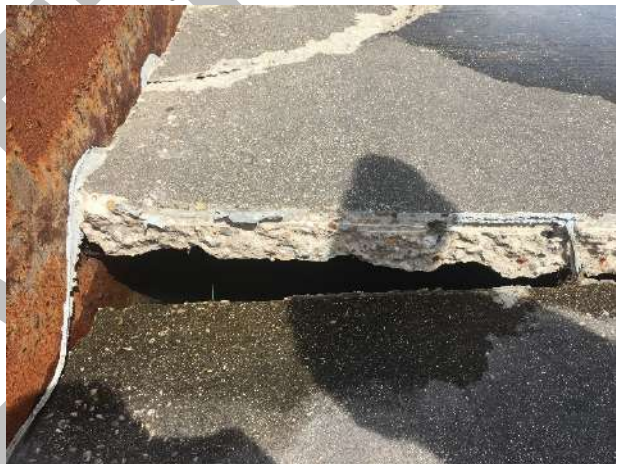
D. Concrete Slab Failure, 5" Thick

During the site inspection, it was observed that fill material was actively leaching out of the cargo box which has led to the collapse of the surface concrete slab. Waves were penetrating the cargo box and running up the concrete slab pieces to impact the leeside wall. In more vigorous events, waves are expected to hit this wall and overtop into the boat launch area. The wall will see wave forces and, not being designed for such impacts in a cantilever state, will bend to absorb these forces which may lead to fatigue cracking.

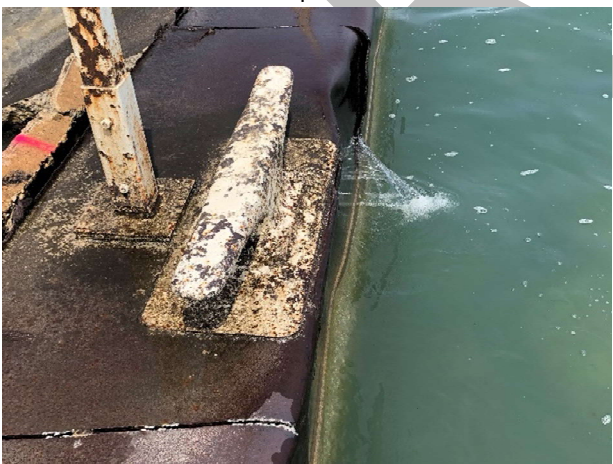
E. Water Escaping through Cracks in Box

The steel hull of the cargo box exhibited many signs of wear. Cracks appear to be from fatigue possibly brought on initially by impact, either by an object or movement of ice. Once the crack forms, continual passing of wave energy will, overtime, exploit the weakness and form an opening in the hull. Any opening in the hull will allow wave energy to pass into the inner chamber.

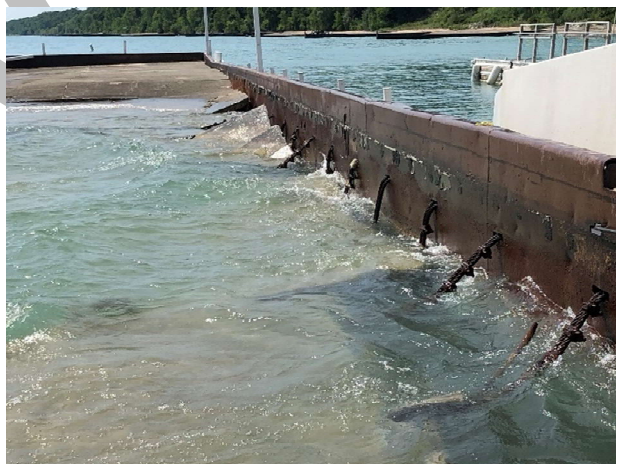
F. Broken Wire Rope Supports

The original construction drawings show the wire rope supports were pushed through the inner hull and looped around wood blocks and L-bracket stiffeners. This created holes in the inner hull which, at higher water levels, creates a space were fill from the interior could leak into the space between hulls. If cracks or holes were to be present, this would further allow that fill material to be pulled out of the cargo box overtime.

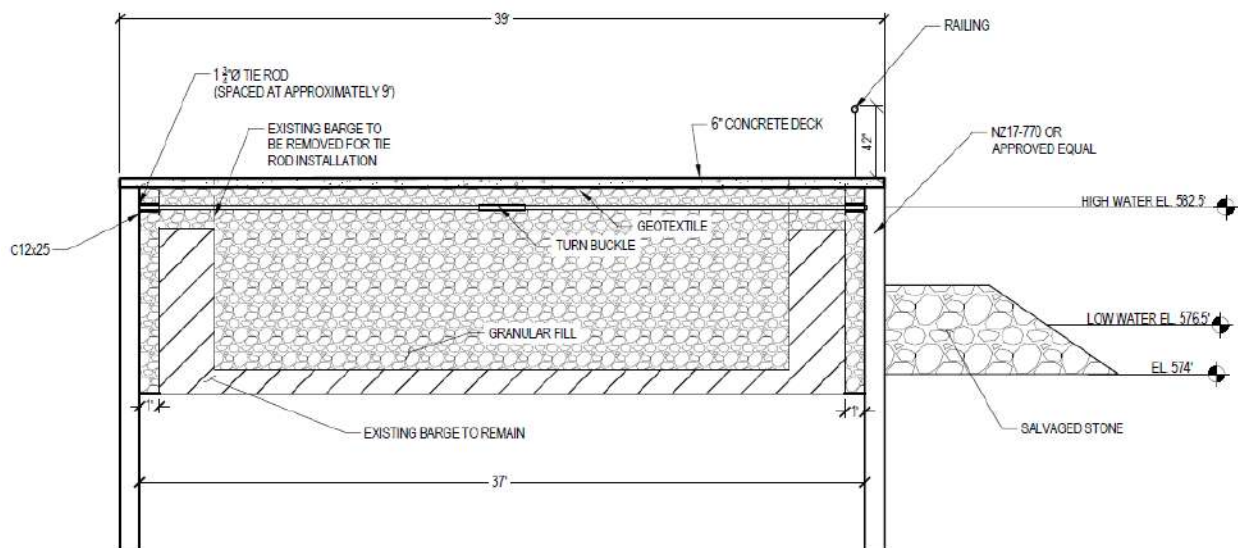
Figure 3 Barge "Repair" Strategy

The damage to the lakeside of the cargo box is significant. As waves continue to enter the open cargo box, the steel surrounding the opening continues to bend and fatigue. At the onset of this project, the simplest repair consisted of removing the full concrete surface, repairing the hole in the cargo box, placing new fill inside the box, and pouring a new concrete slab. However, following the site inspection, repairing the damage locally is not considered an option. The remaining steel cargo box is thin and fatigued making it difficult to weld anything to it that would continue to function in the harsh climate of Lake Michigan. Additionally, welding would have to occur underwater which is expensive and difficult in wave motion.

Recognizing these limitations, it is therefore recommended that the walls of the barge be cut down in order to install sheetpile along all three sides of the barge to encapsulate it. The concrete refuse of the barge can be crushed and reused as fill within the new box. Cut steel and steel surface features of the barge can be recycled. Tie-rods will be attached to the new sheetpile with interior walers to create a solid box which reduces the required embedment depth and therefore sheetpile length. The height of the new concrete deck can mimic the existing barge at 584 IGLD85 or be raised to reduce overtopping during high water events.

In order to encapsulate the barge, sheetpile will need to be driven on the outside of the barge footprint. Leaving a one foot allowance to either side, the new groin structure will have an increased width of approximately 39 feet. It is anticipated the scattered armor stone can be reused to prevent scour along the lakeside wall face.

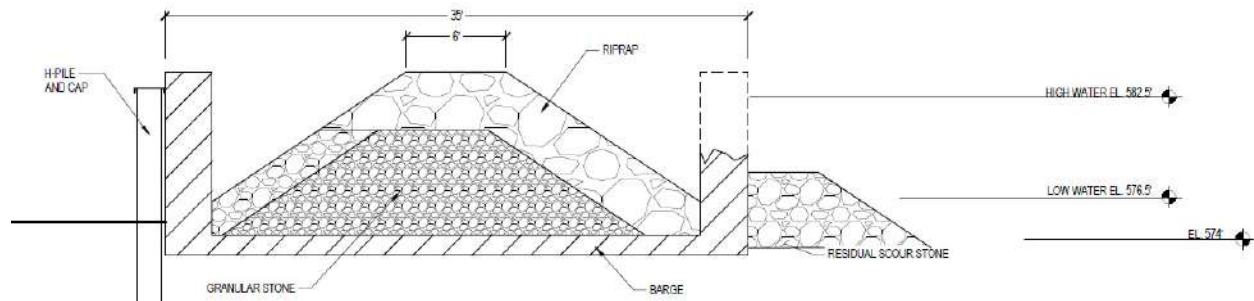
Figure 6 Adaptive Strategy – Rubble Fill

While it is unlikely the cargo box wall will fail imminently, overtime, it will form cracks and start to bend backward. The best option to delay this is to fill the dilapidated cargo box with larger armor stone. Waves will break over the rocks and will lose energy in the process resulting in less pressure on the leeside wall.

Riprap on the order of 2.5 feet in diameter will provide some protection to the inside wall while remaining stable in extreme storms. It is anticipated this will increase the useful life of the cargo box wall by 10+ years. To extend this estimated service life, additional bracing can be added to the leeside cargo box wall. The likely failure mechanism of the wall is fatigue of the steel near the base. Due to zebra mussel encrustation and settlement into the soft soils, the condition of the base of the wall was not visible during the inspection. Therefore, its remaining service life is indeterminate. By installing H-Piles along the backside of the cargo box, the wall will be supported and less likely to fatigue. The piles will support any movement of the wall toward the boat launch.

Installation of such a redundancy will increase the system's service life. While it is impossible to determine an exact length of time this system will remain functional based on unknown deficiencies and the unpredictability of natural weather events, it is our opinion that the combined condition of the rock fill and the support piles will have a service life of 20+ years.
