MILLARD BLUFF SLOPE STABILITY ANALYSIS

MILLARD PARK

Highland Park Lake County, Illinois

July 2, 2021

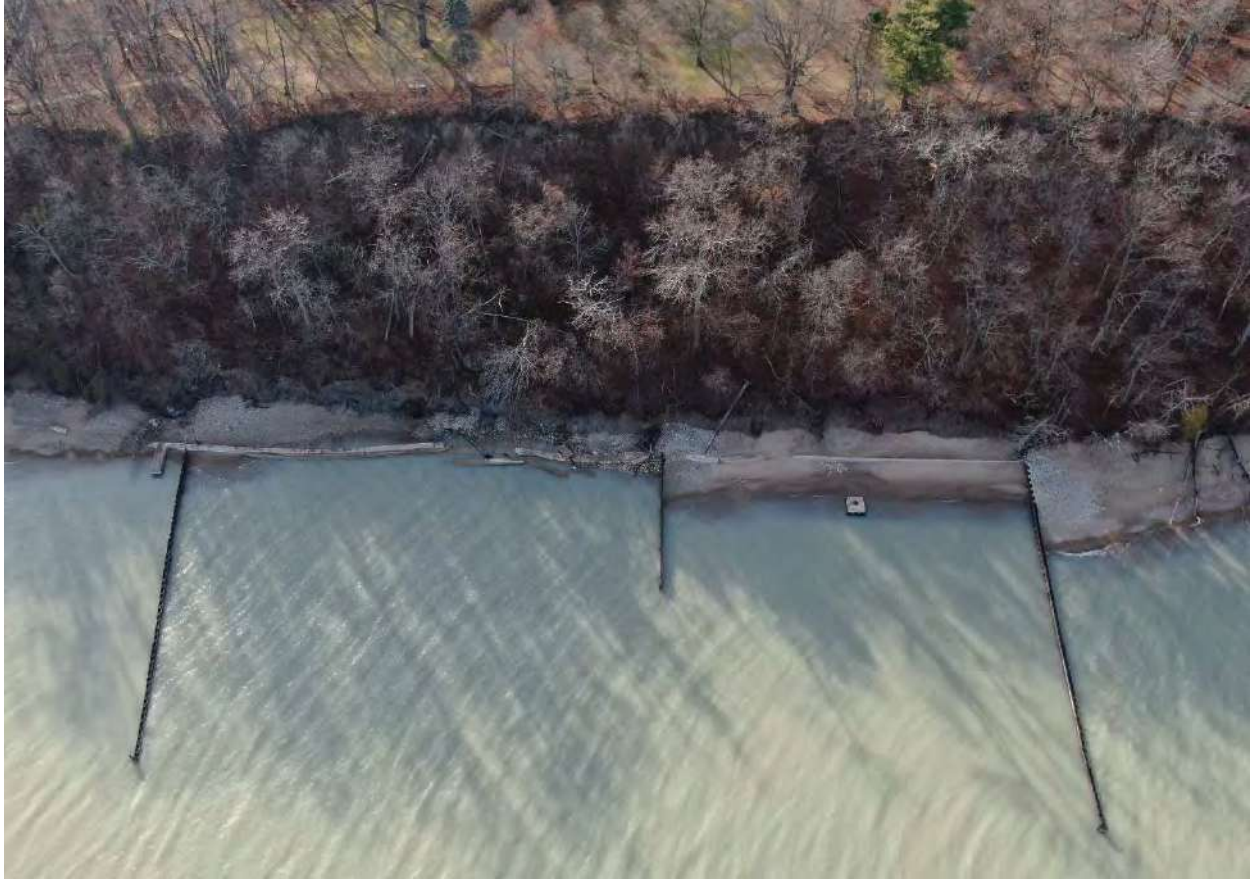
In addition to the sheet pile (jetty) walls a concrete seawall was constructed between the two main sheet pile jetties bounding Section B. Portions of the wall are damaged and allow overtopping water to flow back towards the lake, scouring out the sand behind the lowered concrete wall. Looking at aerial photos of this area (**Figure S.1** below) it is clear that in locations where the seawall is still intact the bluff appears to have somewhat less failure and erosion. Other than the sheet pile jetties and broken section of concrete wall, no existing structures appeared to be in place to prevent erosion at the toe of the bluff.

Figure S.1 Aerial Photo of the Seawall in Section B

The cost of concrete wall repair or sheet pile wall installation between Section B is estimated between \$25,000 and \$50,000 depending on choice of material and total length of wall repair.

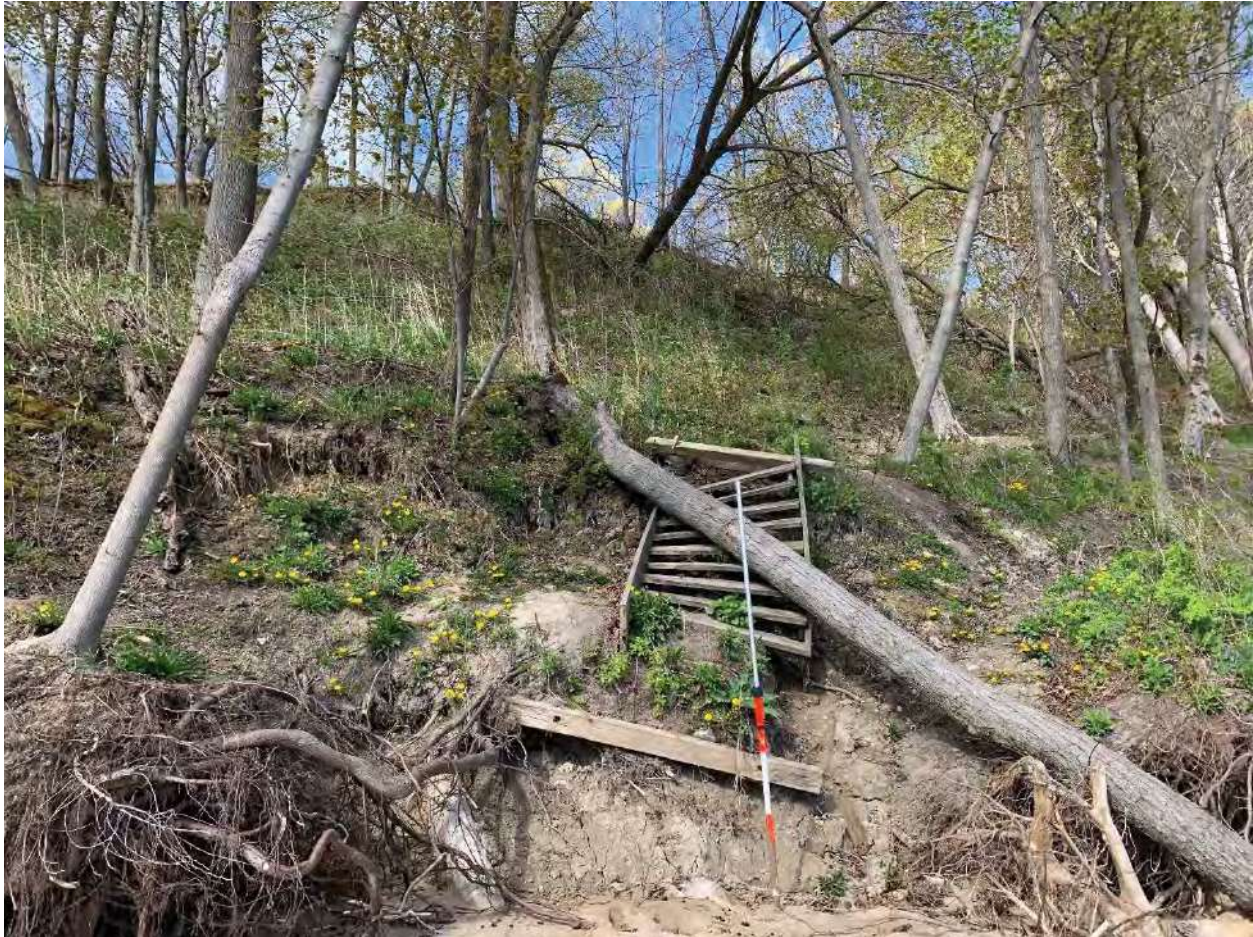
Figure 1.10 Destroyed stair access to beach – also a location expected to fail in the immediate future.

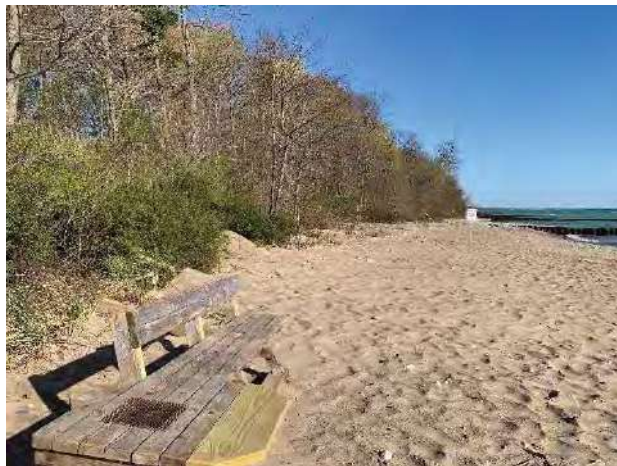
Starting from the south end of Millard Bluff the erosion was minimal and the slope was stable. The slope was measured to be just less than 2H:1V and there was a good amount of beachfront between the toe of the bluff and the edge of the lake (**Figure 2.10**).

Figure 2.10 South end of Millard Park with intact beach.

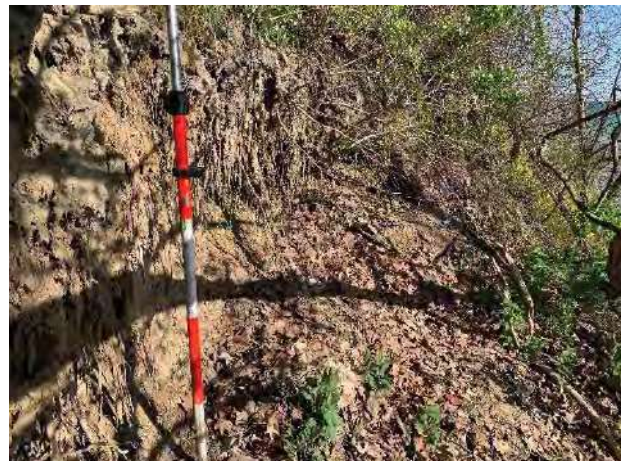
Progressing north along the bluff and up the trail, the slope steepens and the beachfront shrinks. V3 measured a slope of 4H:3.25V at the middle point of Section C where the bluff is unsafe to traverse. Just north of that slope measurement the first major slope failure occurs at the north end of Section C (**Figure 2.11**). This figure shows a vertical drop of about 5'. This slope failure came right up to the edge of the bluff with multiple trees overhanging the failure.

Figure 2.11 Slope failure at top of bluff on north end of Section C.

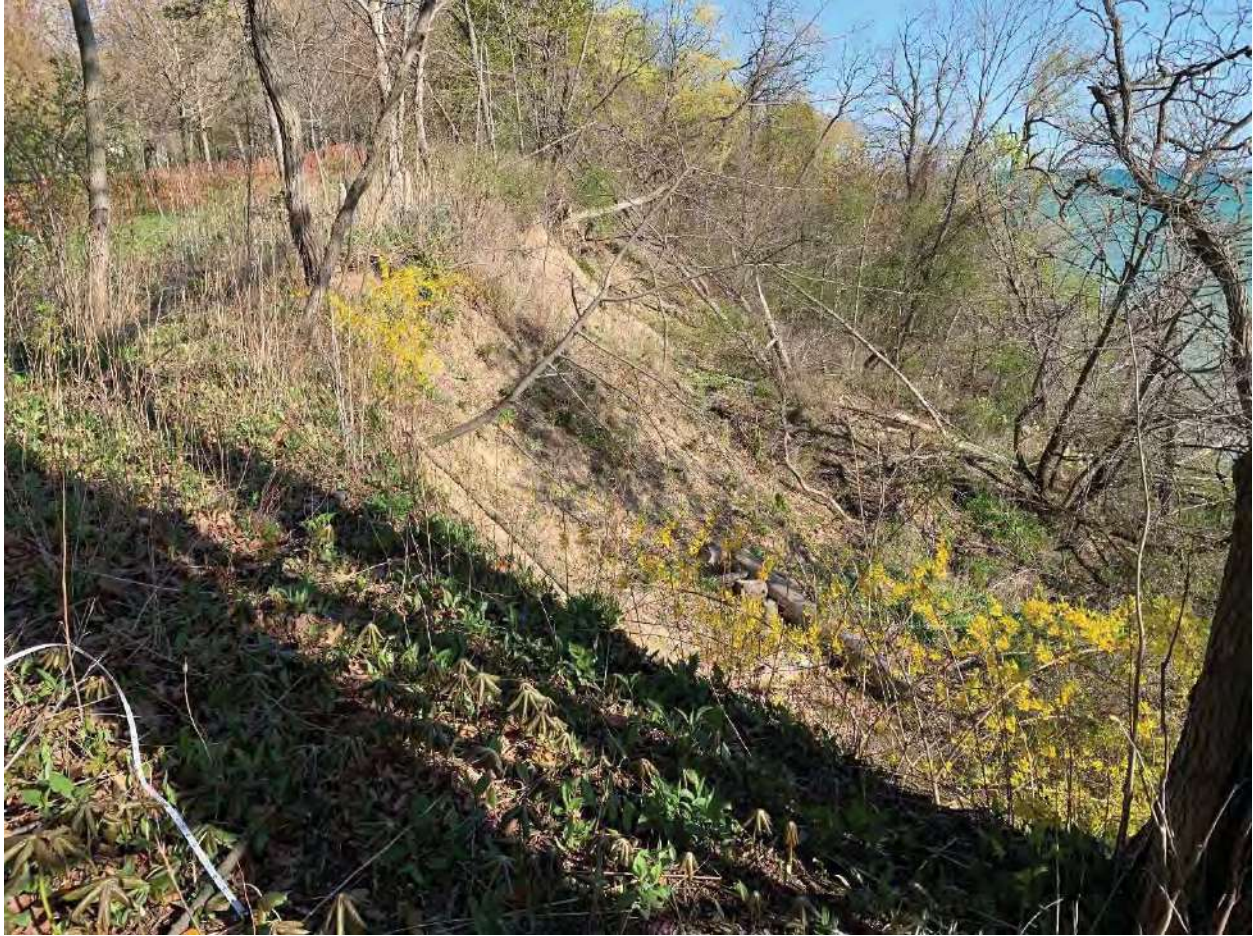
Section B was the worst section for bluff failure condition. Multiple large slope failures exist along the entire bluff. The south end and middle had slope failures with a vertical drop of almost 20' right up to the top of the bluff (**Figure 2.12**). It was not possible to acquire slope measurements at the bottom of these failures, however, it was clear from looking at the bluff that once a failure occurred the resulting slope was around a 2H:1V or even shallower. In fact, this sloughing was quite noticeable along the top of the bluff. There were clear areas where the slope was steep and had previously failed and below it the bluff leveled out until it reached another failure and the process repeated.

Figure 2.12 Large slope failure in Section B

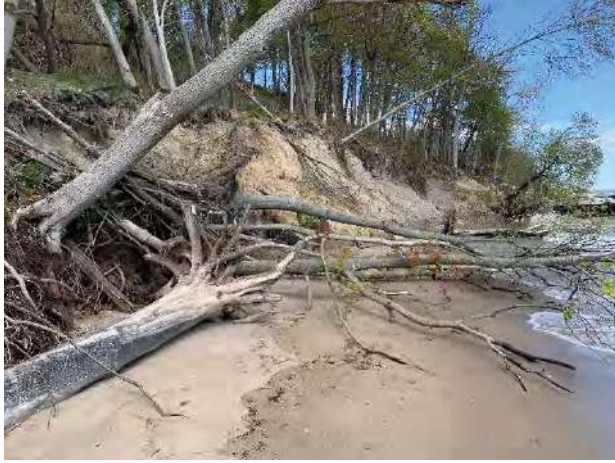
Figure 2.13 Bluff erosion along the beach in Sections A & B.

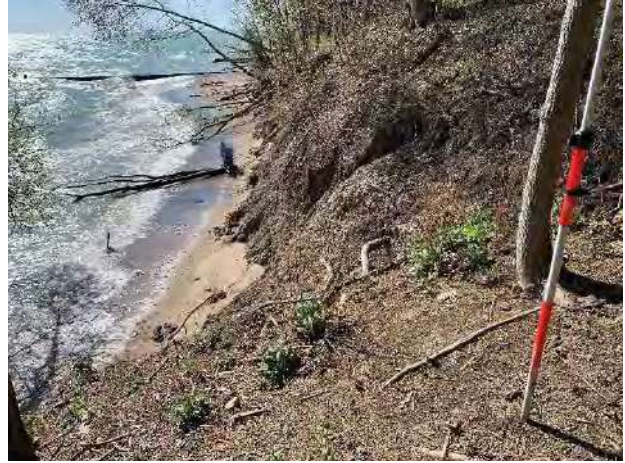
Figure 2.14 Major erosion at the very north end of Millard Park.

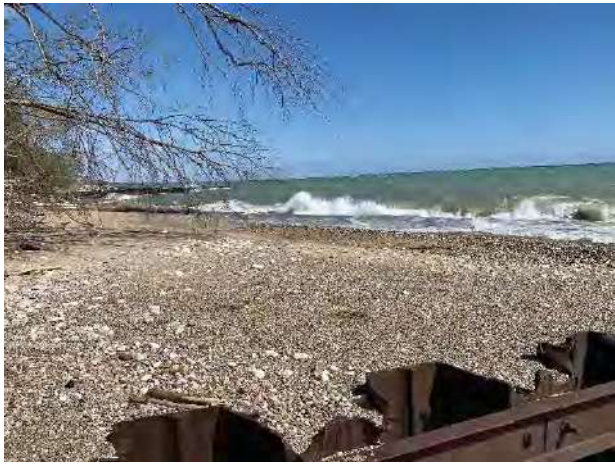
Figure 2.15 Beach front that had been protected due to the existing jetty.

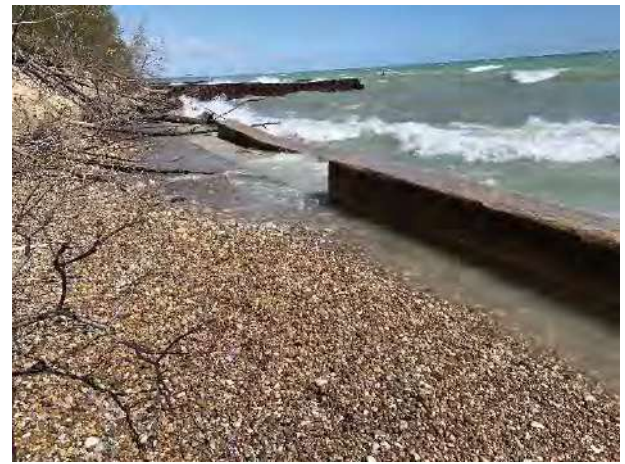
Figure 2.16 Scouring that is occurring behind the breached seawall.

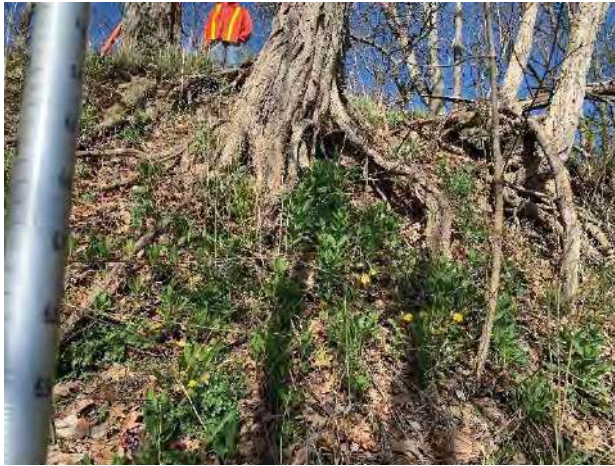
Figure 2.21 Exposed root system due to erosion at north end of Section C.

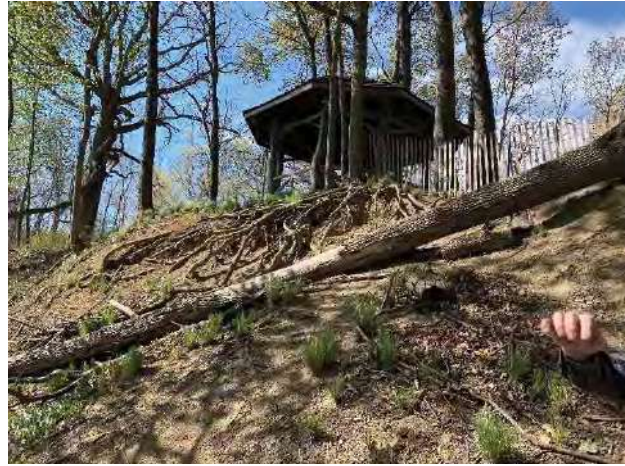
Figure 2.22 Exposed root system at the north end of Millard Park.

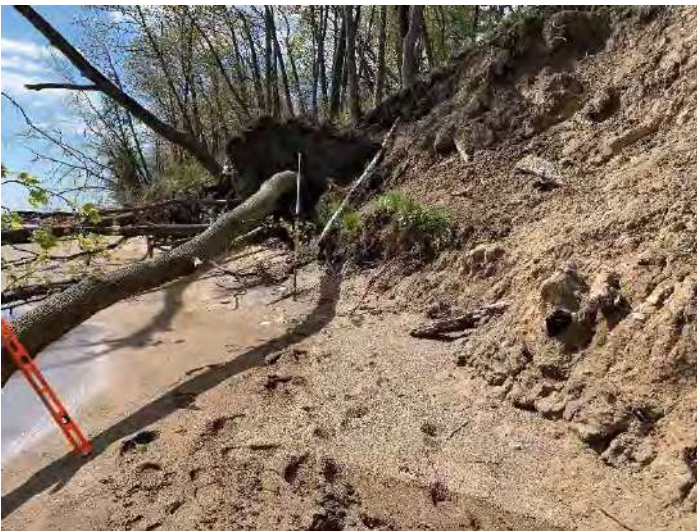
Figure 2.23 Fallen tree along the beach showing the uprooting that can occur.

Although trees and their root systems can often assist with slope stabilization, when they fail, they can contribute to larger and more significant slope failures. This is because the root ball and extra soil pulls out of the slope resulting in a larger failure zone. This could be seen along the beach front where trees had fallen onto the beach and large sections of bluff vegetation and topsoil were pulled away from the slope (**Figure 2.23**).

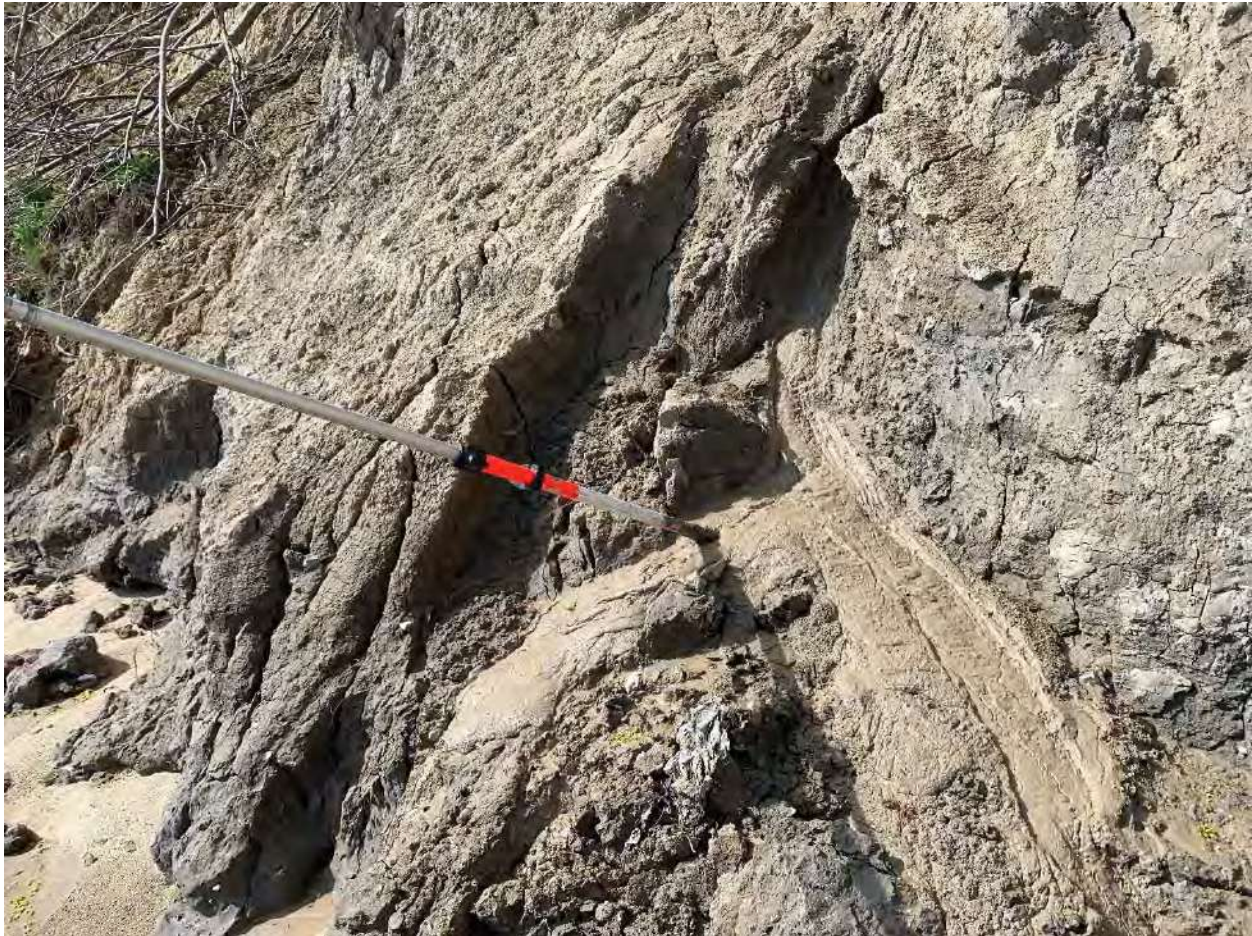
Figure 2.31 *Liquifying soil seeping out the face of the bluff along the beach due to excessive soil saturation.*

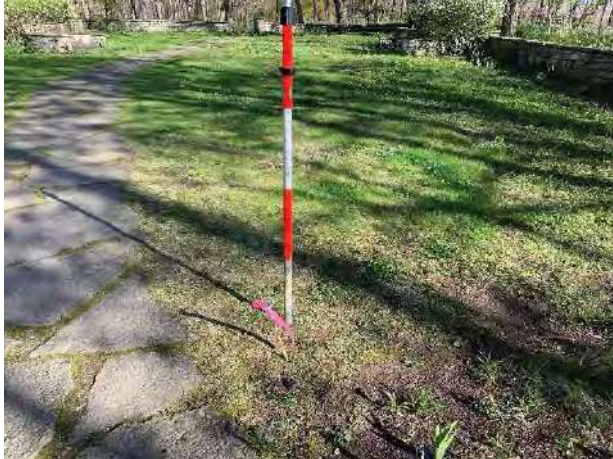
Figure 2.32 Sprinkler head at the top of the bluff on the south end of the flower garden.

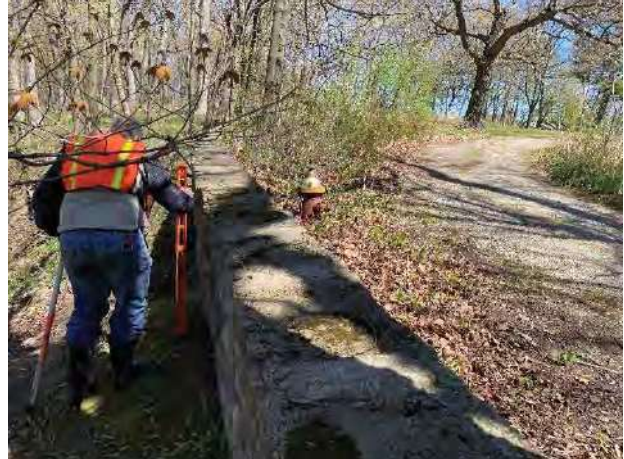
Figure 2.33 Fire hydrant at the northern end of Millard Park on the west side of the bluff.

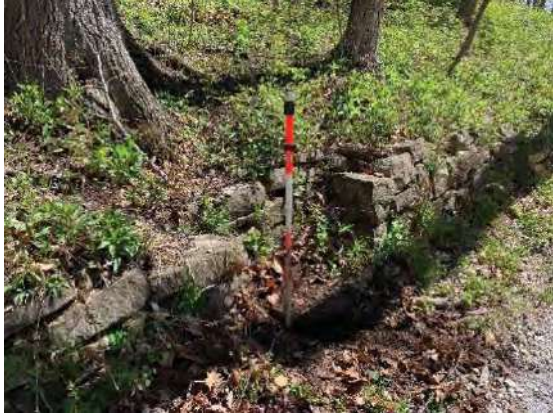
Figure 2.34 Drainage inlet found along Millard Park path.

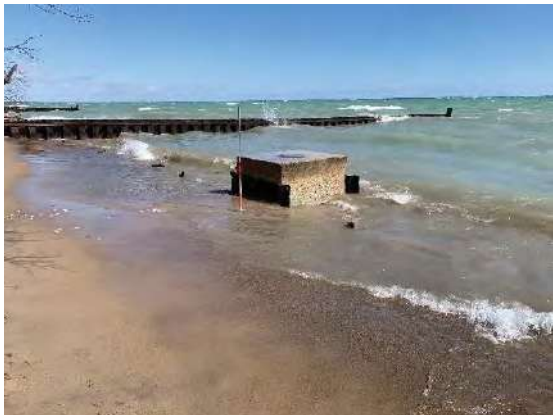
Figure 2.35 Probable MWRD interceptor sewer structure at bottom of bluff.

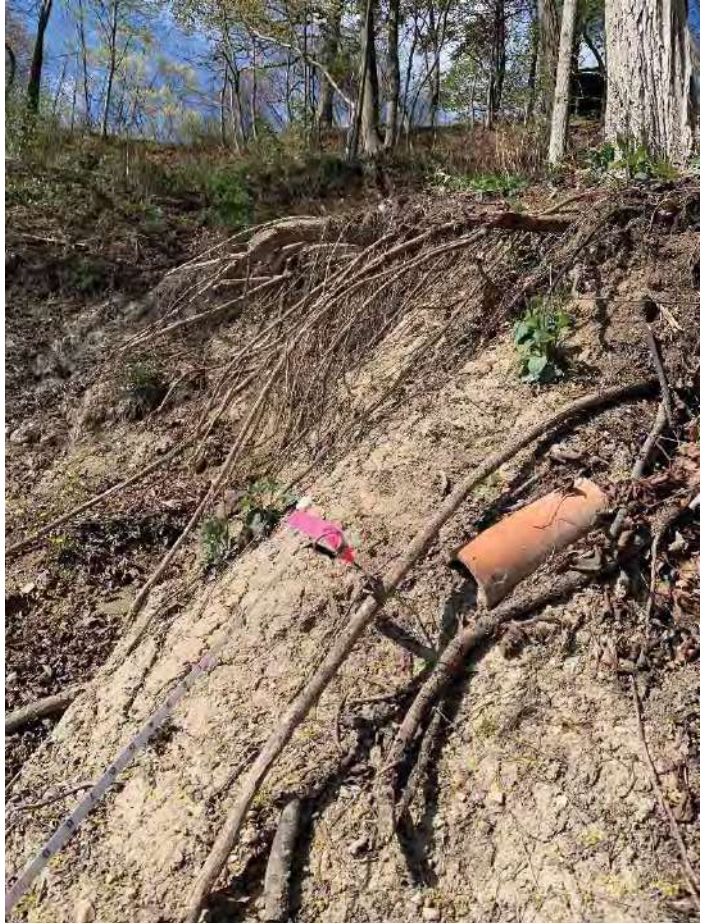
Figure 2.36 Piece of clay pipe. Possibly a section of an old drainage system.

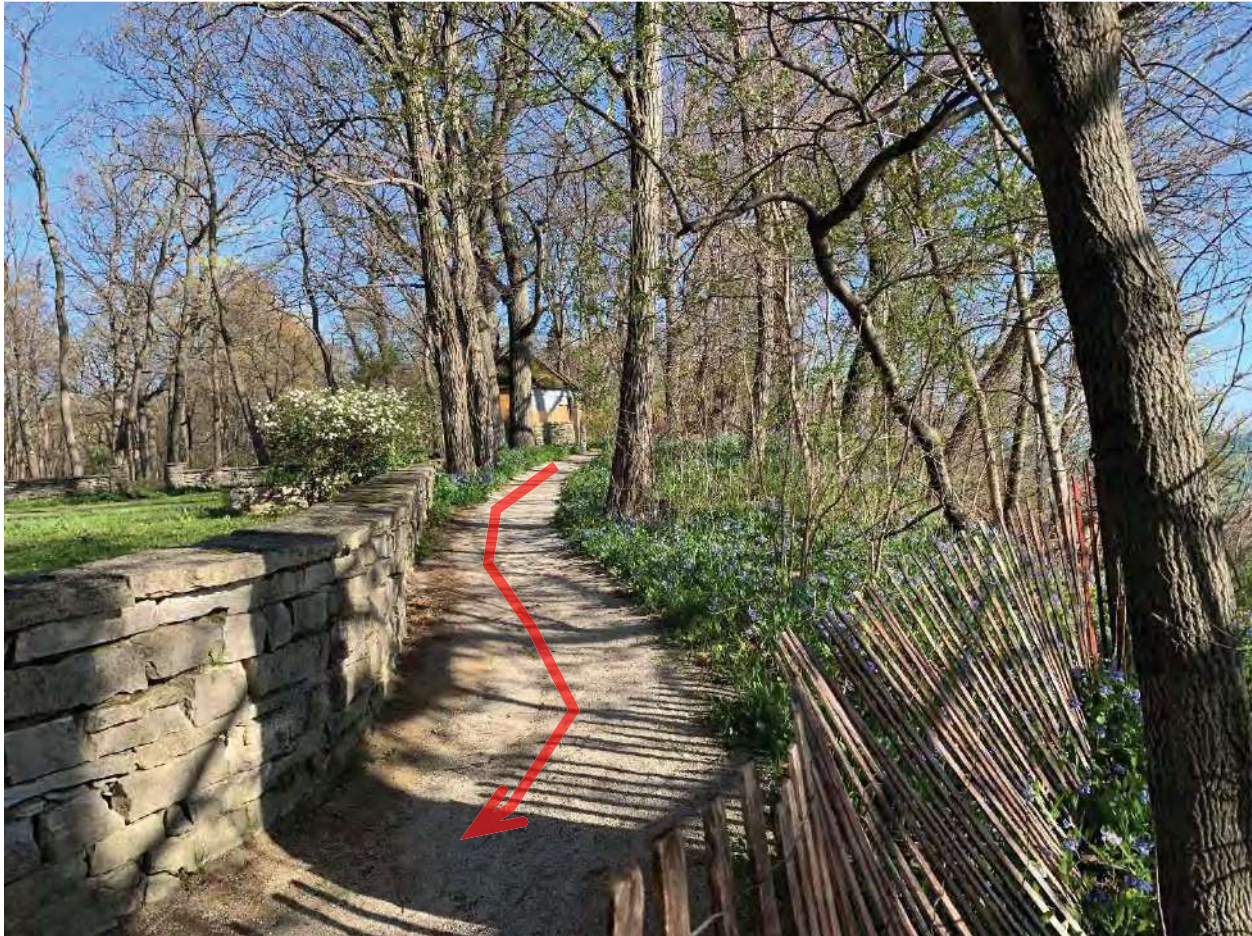
Figure 4.41 Existing top of bluff path being used to focus accumulations of drainage to bluff top edge

Therefore, V3 recommends relocation of the trail to an alignment a minimum of thirty feet back from the present top of bluff edge. As a part of this effort, V3 recommends re-grading of the previous path alignment where accumulated runoff drainage was inadvertently being directed to the edge of bluff (**Figure 4.41** below). This re-grading should be performed in such a manner as to direct the accumulated drainage to a more suitable outlet

such as the stable ravine and installed storm drainage system to the west side of Millard Park (preservation of ravine stability must also be a priority in this construction effort).

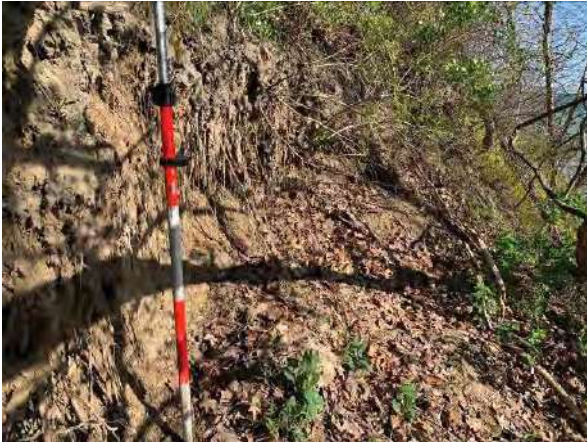
Picture 1: Vertical drop due to slope failure.

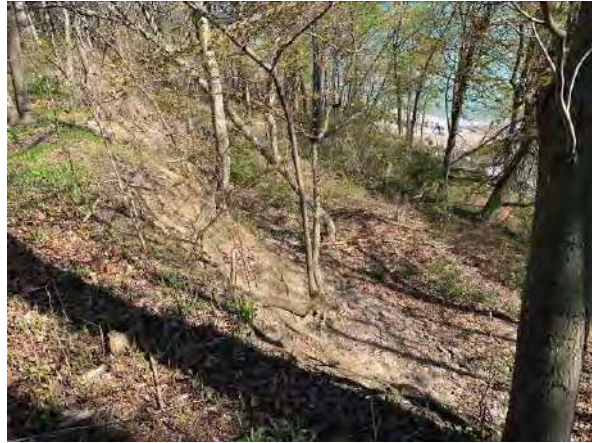
Picture 2: Slope Failure.

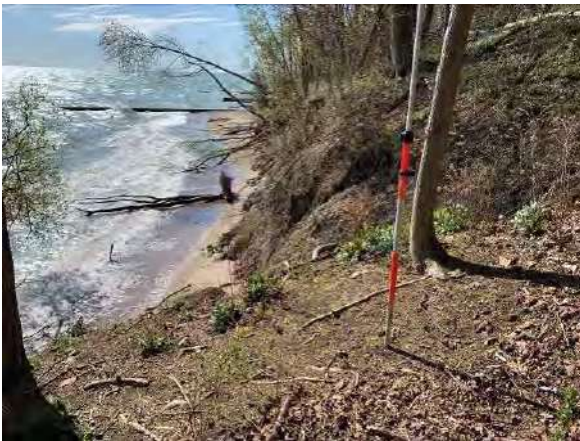
Picture 3: Major erosion and slope failure at beach.

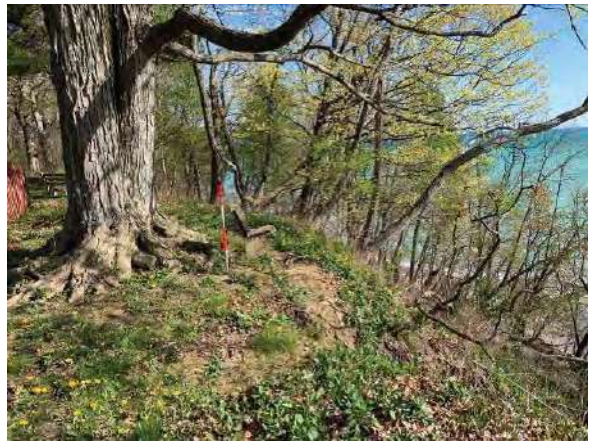
Picture 4: Tree in slope failure zone.

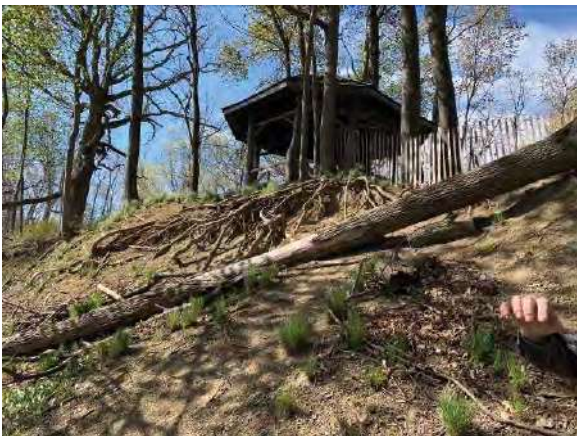
Picture 5: Exposed root system due to erosion.

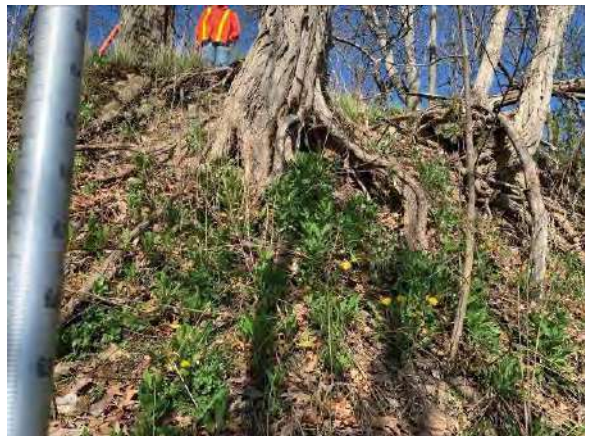
Picture 6: Exposed root system due to erosion.

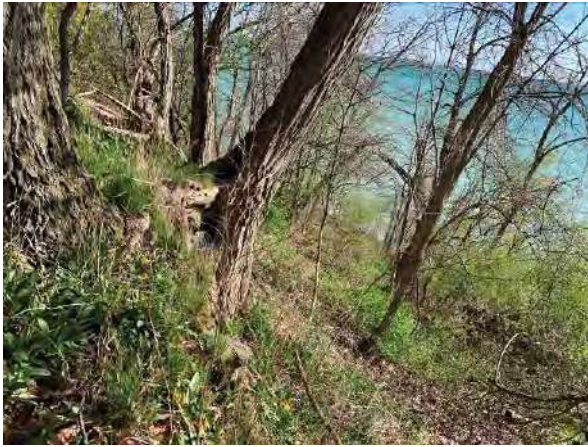
Picture 7: Tree in slope failure zone.

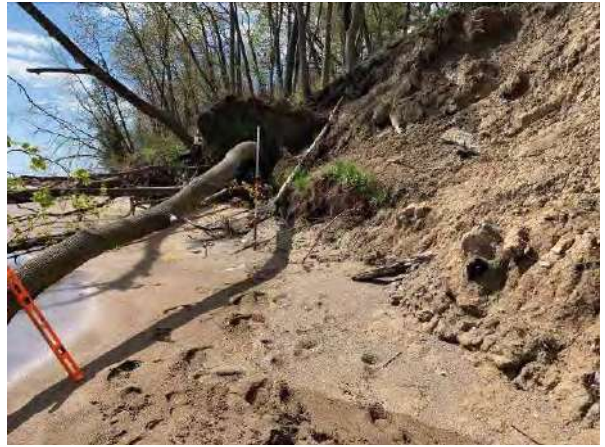
Picture 8: Tree failure showing uprooting.

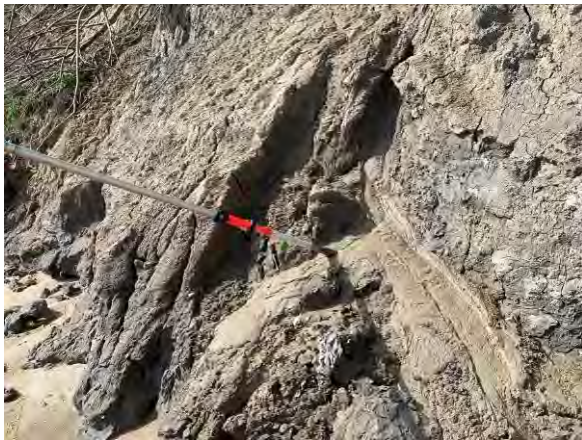
Picture 9: Soil seepage at base of bluff along beach.

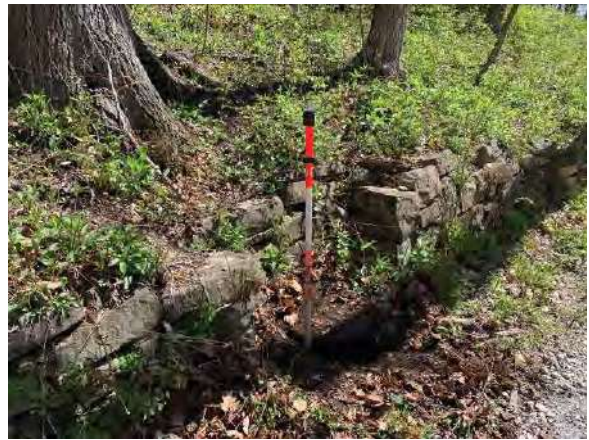
Picture 10: Storm sewer inlet.

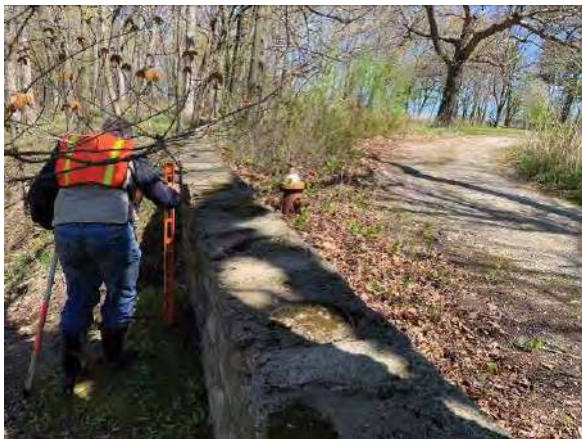
Picture 11: Fire hydrant still in use?

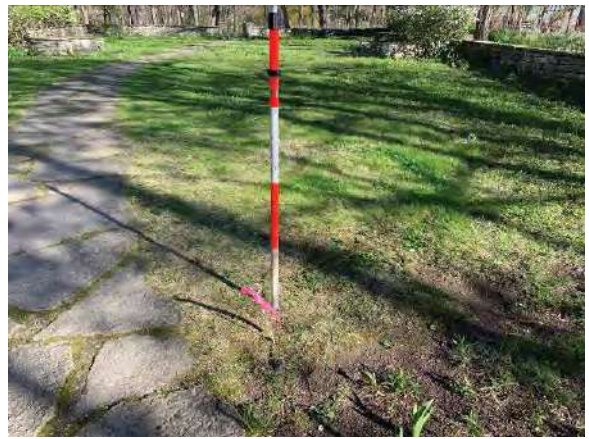
Picture 12: Sprinkler head still in use?

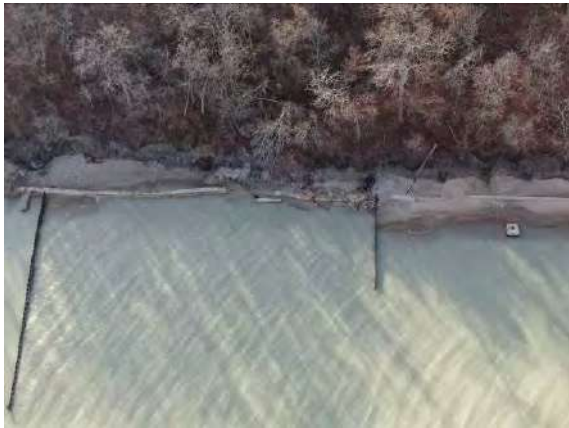
Picture 13: Aerial photo of deteriorating seawall on southern half of Section B.

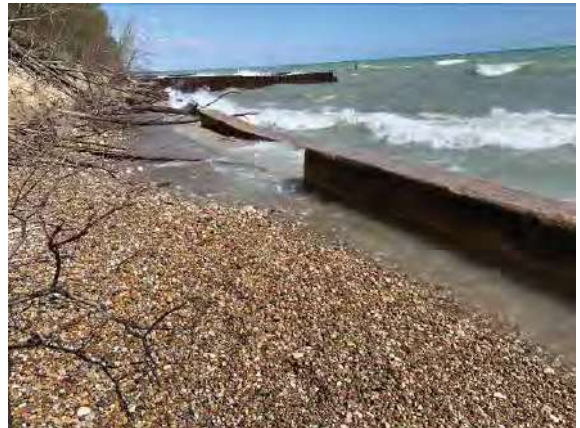
Picture 14: Washout occurring behind the seawall on the south of Section B.

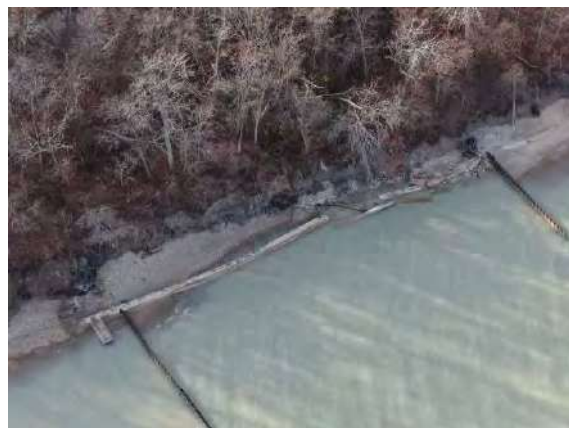
Picture 15: Slope failure behind seawall on south half of Section B.

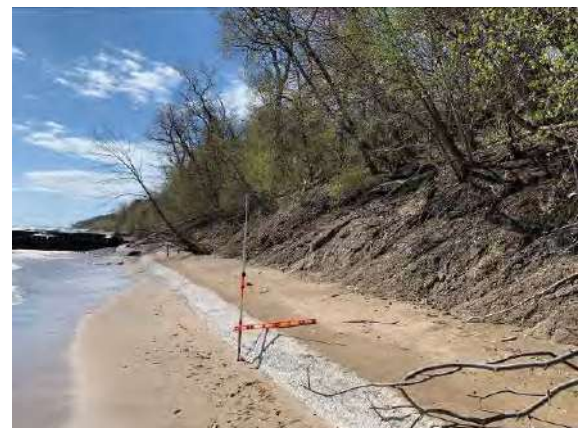
Picture 16: Priority Tree Removal area on north end of Section B looking south.

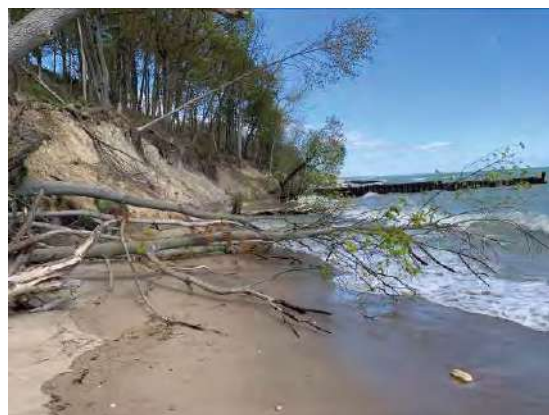
Picture 17: Priority Tree Removal area on south end of Section A looking north.

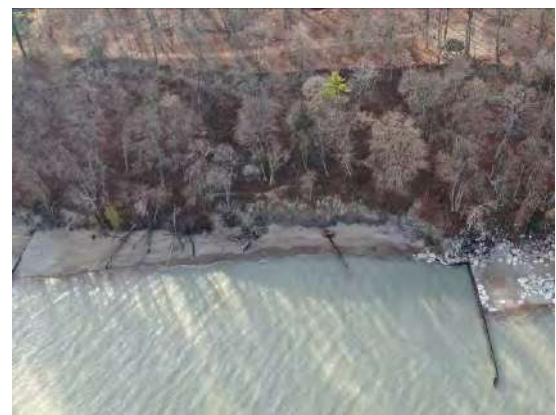
Picture 18: Aerial photo of slope failure on north end of Section A.
