TRACK 1: RECREATION CENTER OF HIGHLAND PARK IMPROVEMENTS

TRACK 1: CENTENNIAL ICE ARENA IMPROVEMENTS

TRACK 1: SUNSET VALLEY GOLF COURSE IMPROVEMENTS

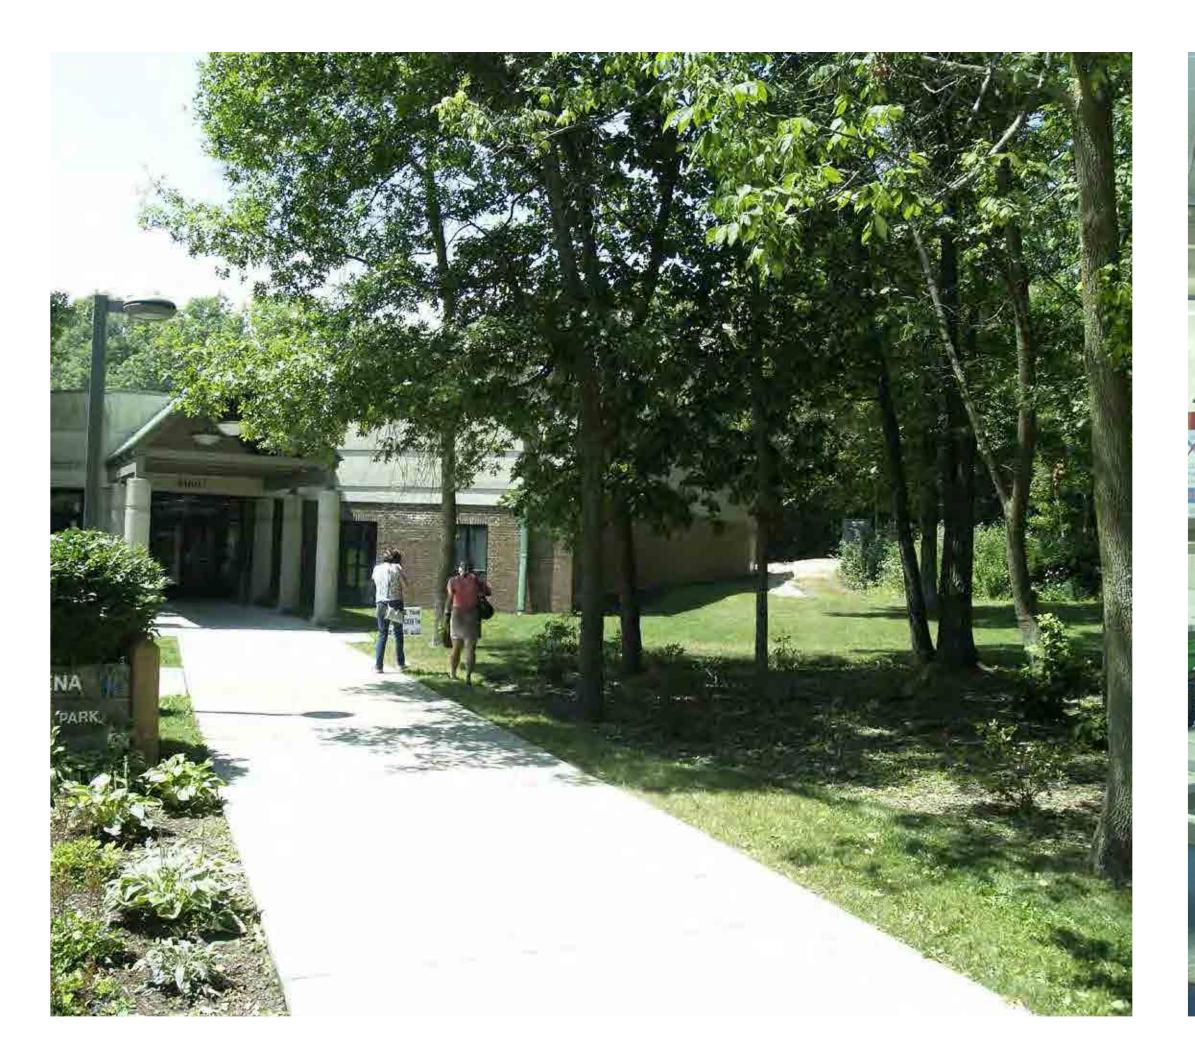
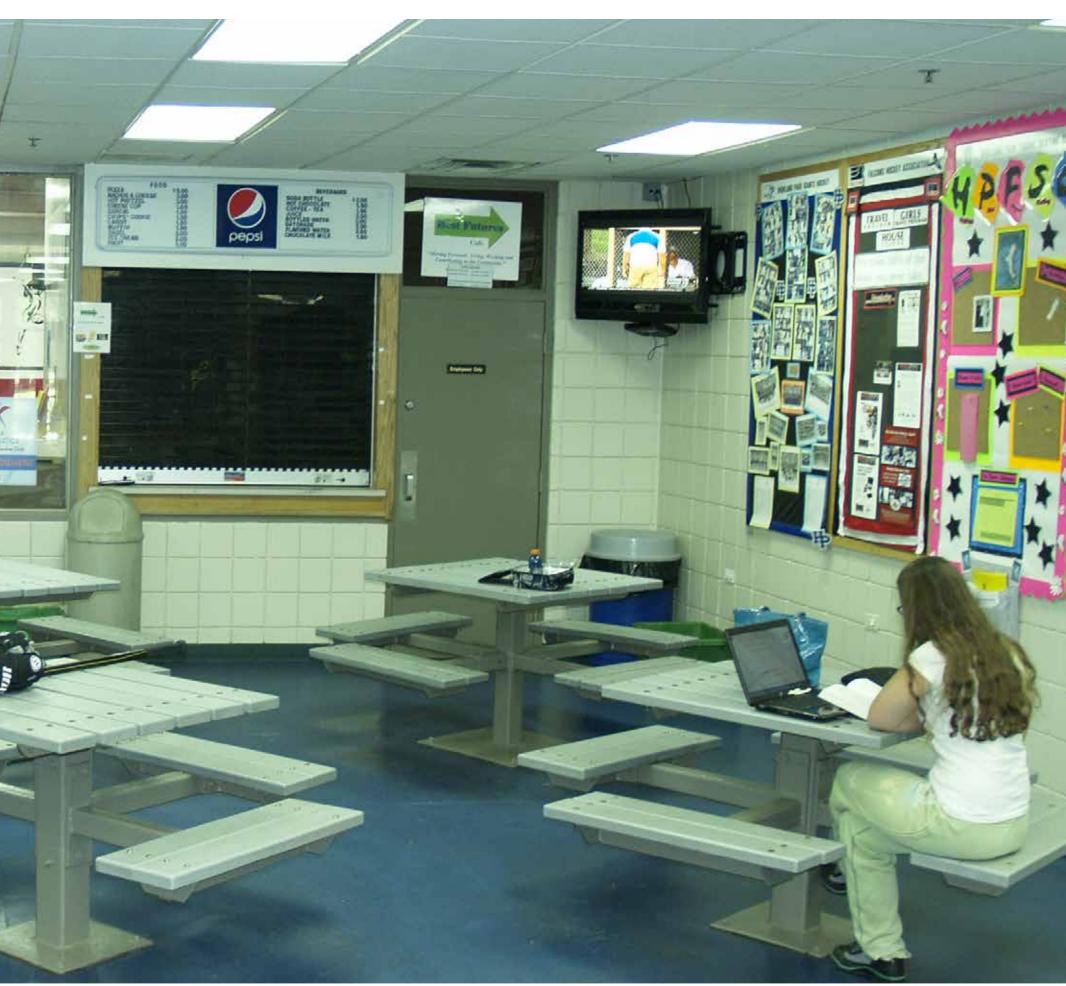
BUILDING + SITE CONDITION

- Finishes are dated, not up to the expectations of the community
- Condition is good
- Upgrades were made to the bathrooms in 2002, and rubber flooring was replaced in 2001

- Exterior finishes are sound, aesthetically acceptable, and in good condition
- Humidity migration and condensation occur at the roof edge
- Exposed electrical conduit next to spectator bleachers is a concern

- Fire panel was recently repaired, however, the Simplex fire alarm system is outdated
- Facility is not ADA compliant
- Power outages occur, generator is scheduled to be installed

- Electrical switch gear is obsolete
- Cooling tower is scheduled to be replaced
- Sanitary sewer backs up under certain conditions.
- The building is subject to flooding, runoff water flows toward the building from the west, keeping drains clear is critical to preventing water from coming into building

- Lack of parking for large events
- Site lighting level is too low for patrons to feel safe at night.

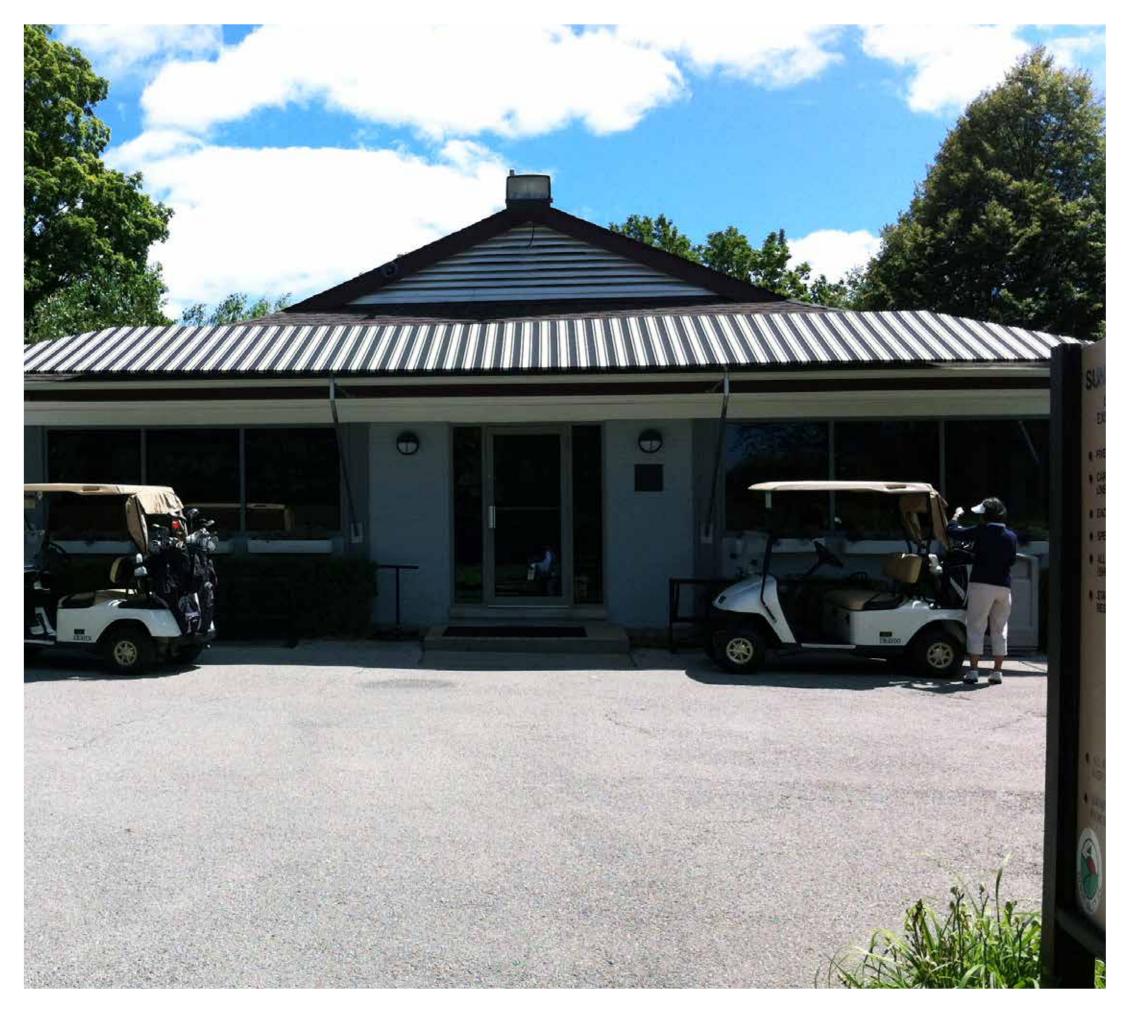
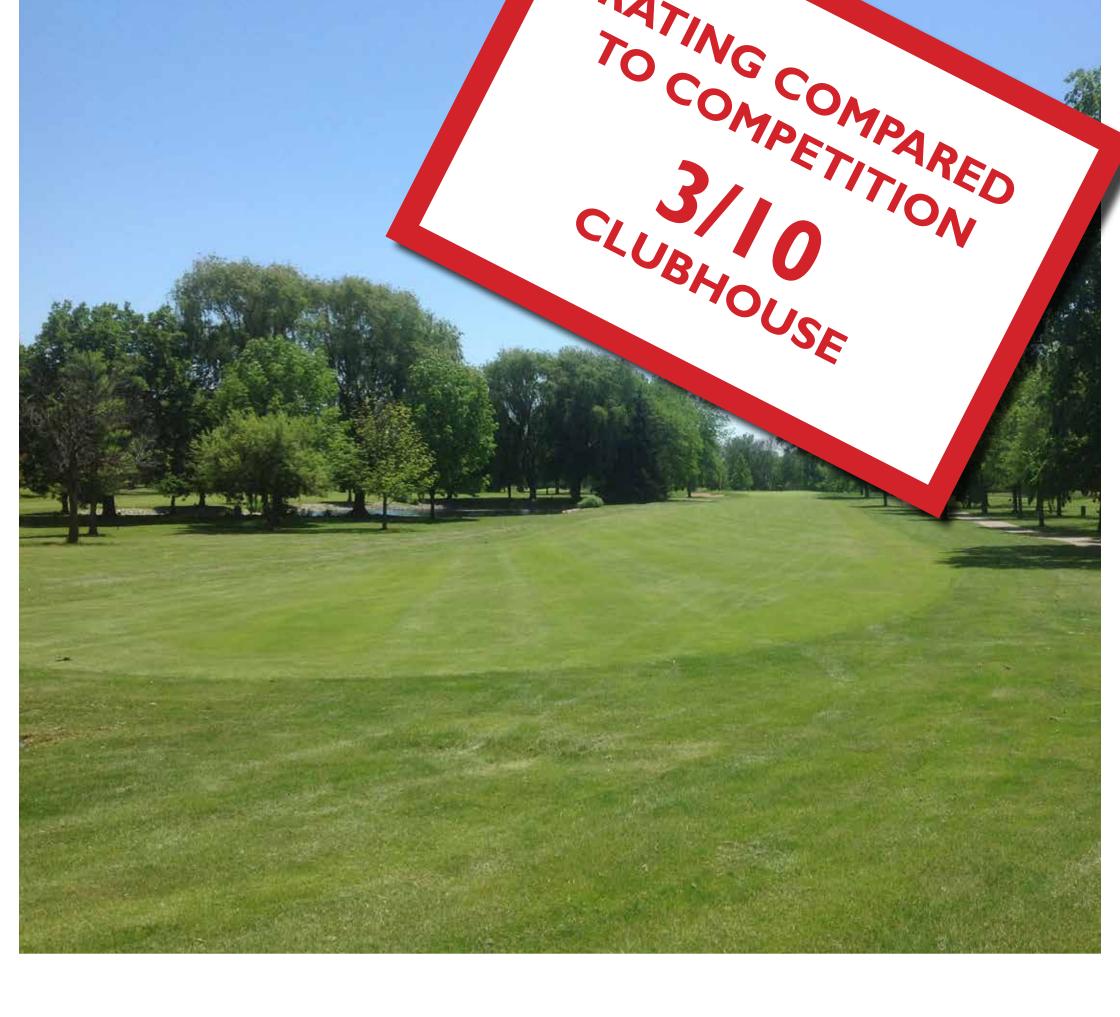
BUILDING + SITE CONDITION

- Good
- Very basic and well maintained
- The interior has an institutional look, lacks a club house feel
- The exterior is charming and fits well with the site
- No significant issues reported, the original building was built in 1921 and expanded
- Basement periodically floods
- There is no fire sprinkler system
- The a/c system requires attention every year
- Air handlers are located in the attic and a/c condensers are outside
- Equipment in attic poses maintenance challenges
- Plumbing issues include mixing of the hot and cold water supplies.
- There is a lack of parking for golfers and staff, total capacity is around
- The parking lot is in rough shape
- The location is difficult to find
- Due to site constraints and neighborhood location, deliveries to the building are difficult.

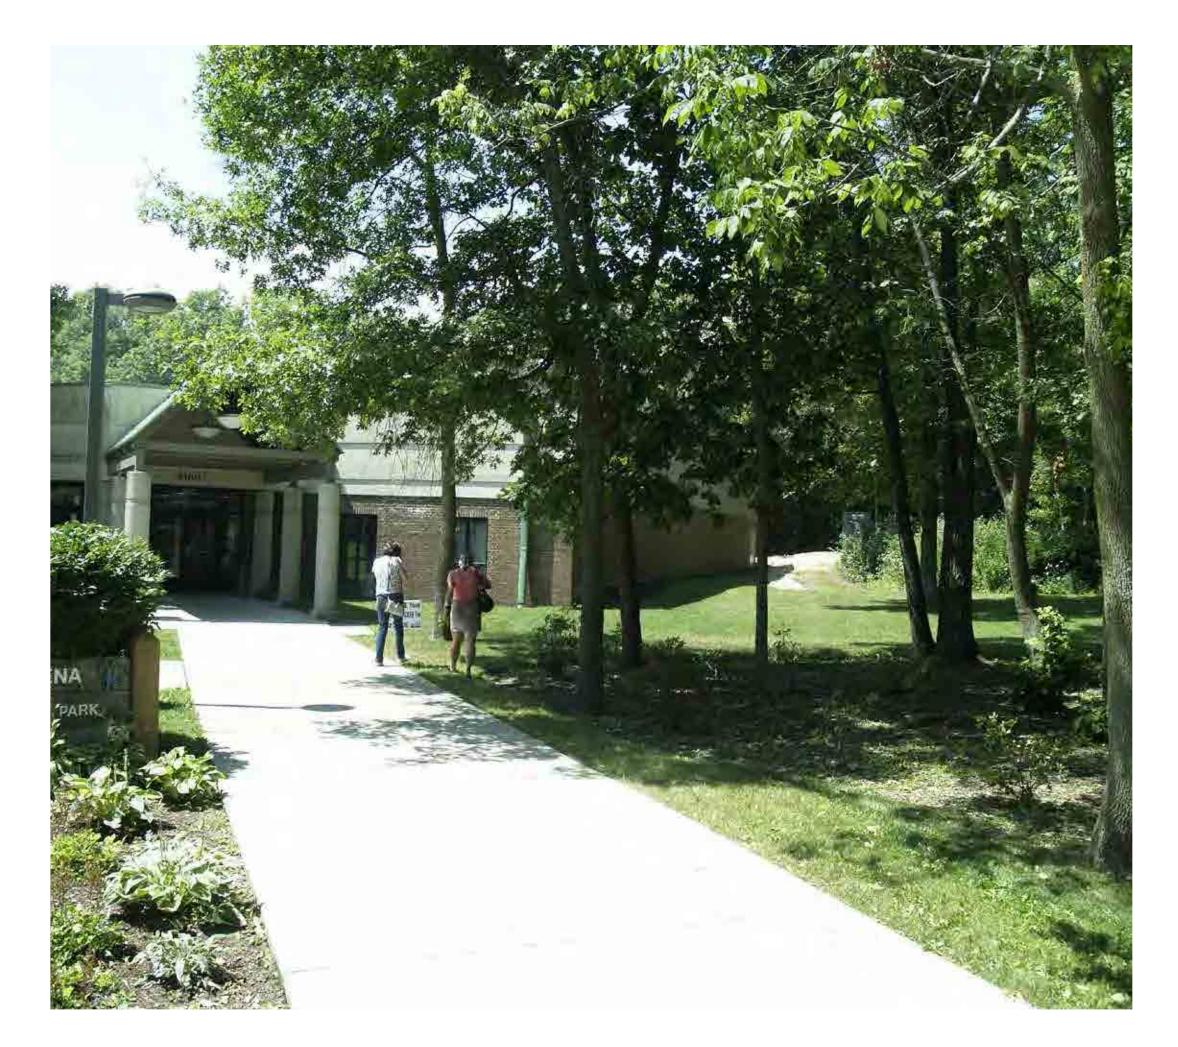
BUILDING + SITE CONDITION

- Finishes are dated, not up to the expectations of the community
- Condition is good
- Upgrades were made to the bathrooms in 2002, and rubber flooring was replaced in 2001

- Exterior finishes are sound, aesthetically acceptable, and in good condition
- Humidity migration and condensation occur at the roof edge
- Exposed electrical conduit next to spectator bleachers is a concern

- Fire panel was recently repaired, however, the Simplex fire alarm system is outdated
- Facility is not ADA compliant
- Power outages occur, generator is scheduled to be installed

- Electrical switch gear is obsolete
- Cooling tower is scheduled to be replaced
- Sanitary sewer backs up under certain conditions.
- The building is subject to flooding, runoff water flows toward the building from the west, keeping drains clear is critical to preventing water from coming into building

- Lack of parking for large events
- Site lighting level is too low for patrons to feel safe at night.

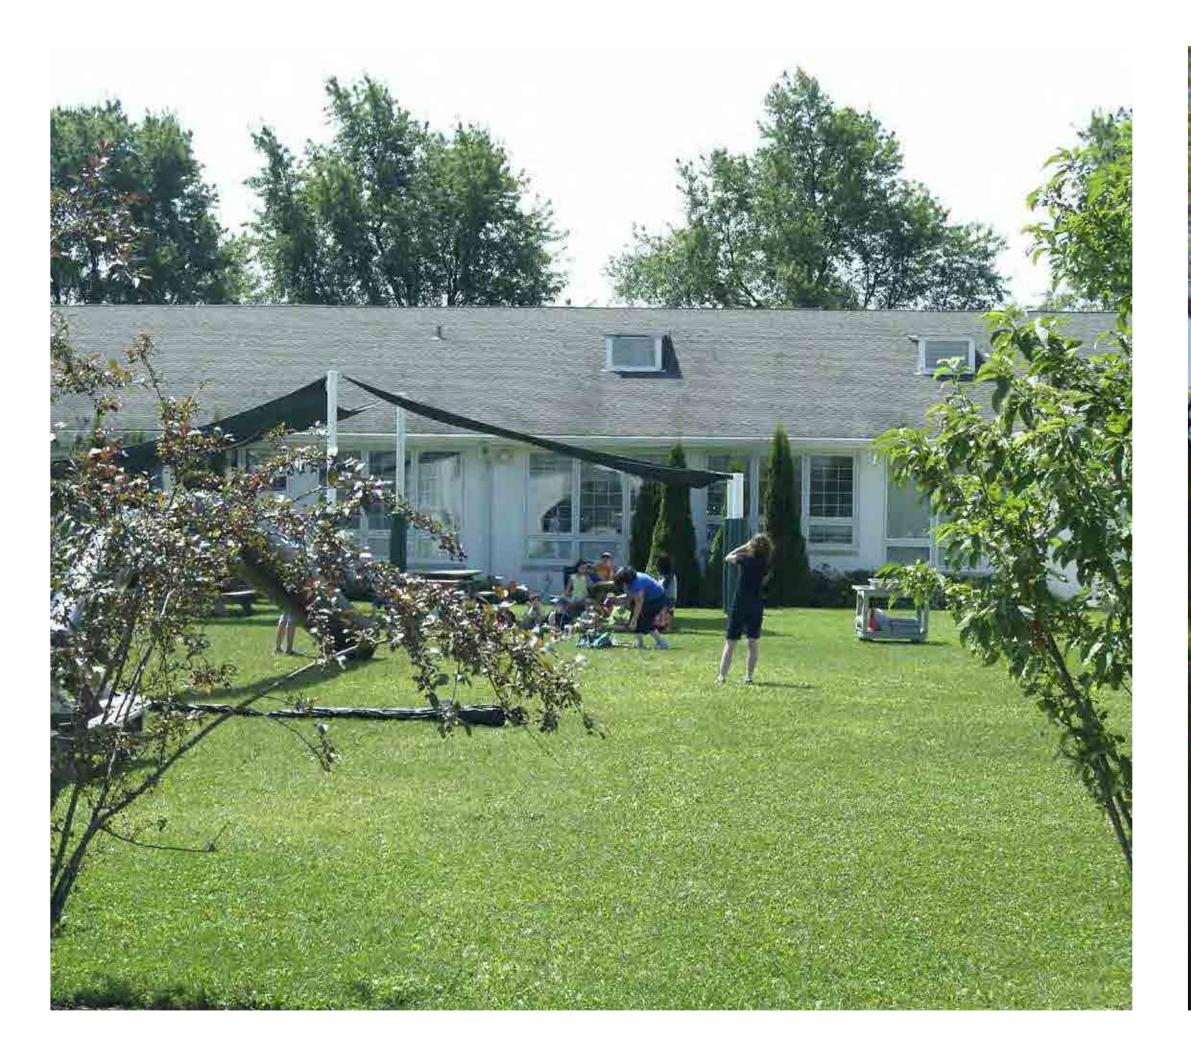
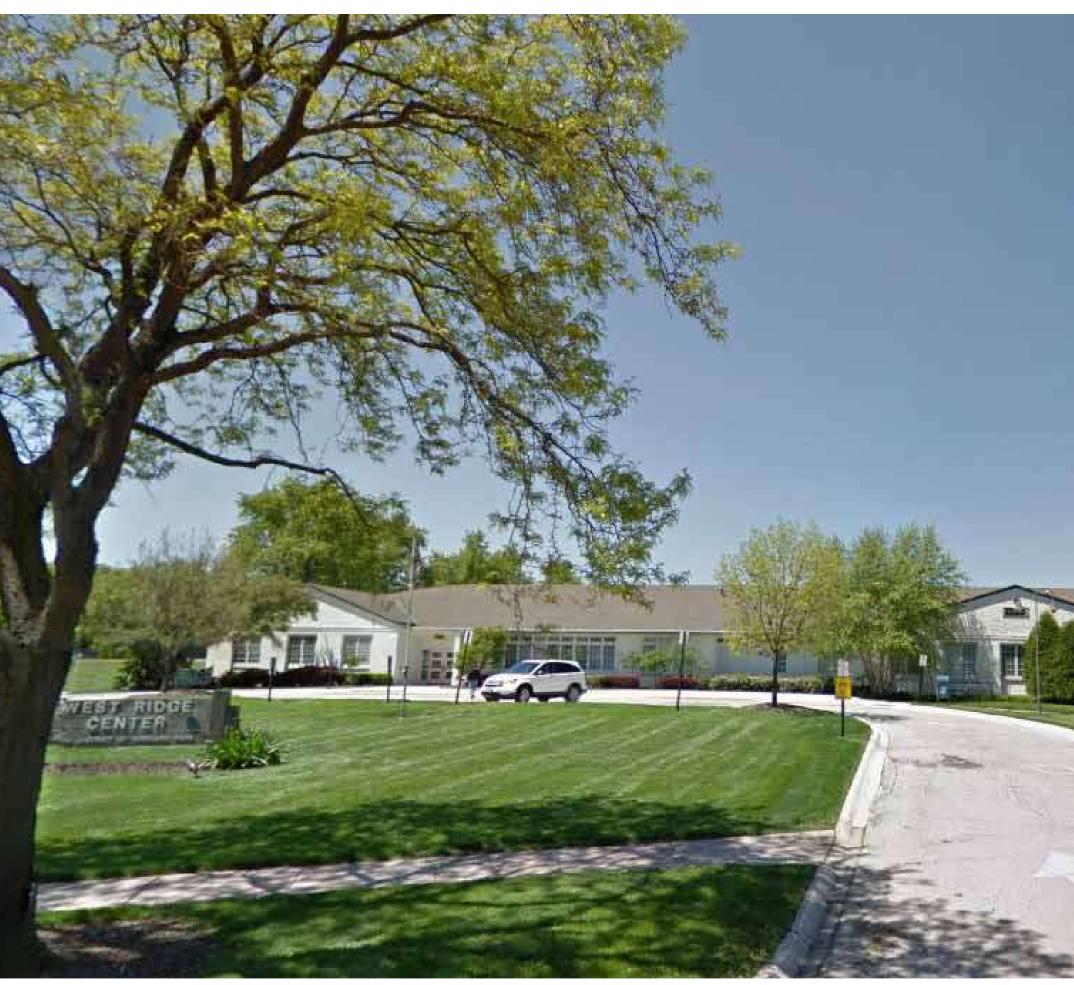
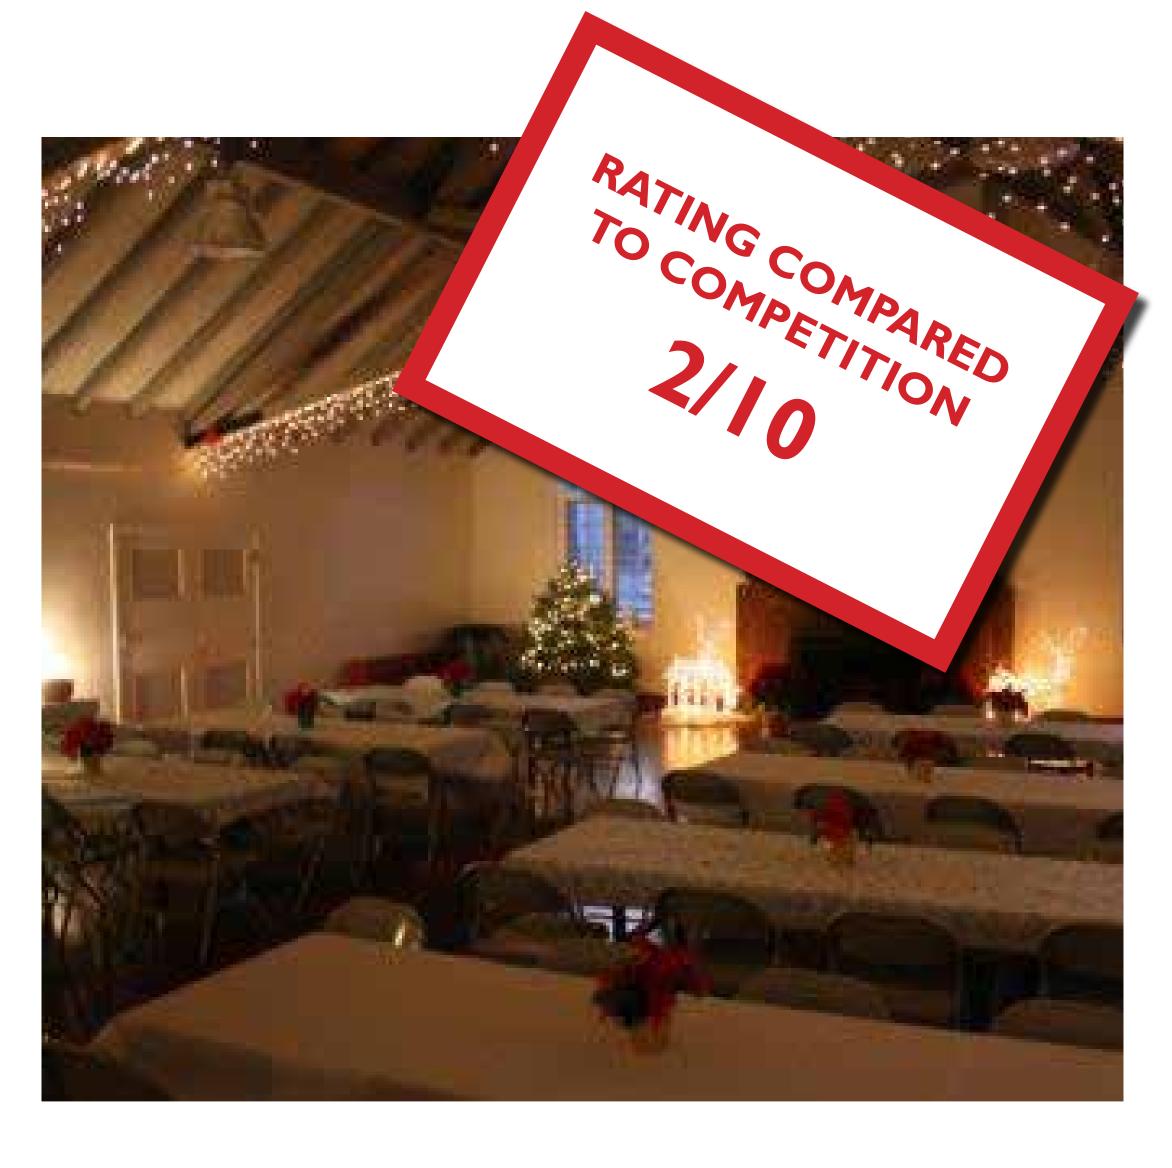
BUILDING + SITE CONDITION

- Interior condition is old, worn
- Windows are old and need to be replaced, project was started but is on hold
- Due to diligent maintenance, condition is good, but not energy efficient

- Roof was re-shingled in 2005
- Brick veneer is deteriorating
- Suspicion that hazardous materials, especially in basement, are causing health issues - abatement is ongoing, there is a concern about indoor air quality

- Flooding has caused mold and humidity issues
- Toilet rooms produce odor
- Gyms get hot (no A/C); attic gets too hot, systems are obsolete and in old / poor condition

- Electrical system shorts out in ceramics room
- Many HVAC issues
- A/C was introduced using window units and other types of remote units
- Rusty water pipes, staff will not drink water

- Domestic hot water system doesn't operate properly
- Boiler / hot water heating system is only 78% efficient.
- Building has a tendency to flood, site pitches toward the building

- Good location
- Parking capacity is good
- Exterior pole lighting is outdated.
