NOTICE OF WORKSHOP MEETING

WORKSHOP MEETING AGENDA

A. Approval of the Beach Management Plan

This beach management plan provides recommendations for protecting and managing the Park District of Highland Park's beaches, bluffs, ravines, and other lakefront properties at Moraine Beach, Park Avenue Boating Facility, Millard Beach, and Rosewood Beach. The recommendations provided in this plan are based on an evaluation of the existing conditions found at the beaches, uses associated with the beach, and a review of lake and habitat conditions. The recommendations provided are specific to each beach.

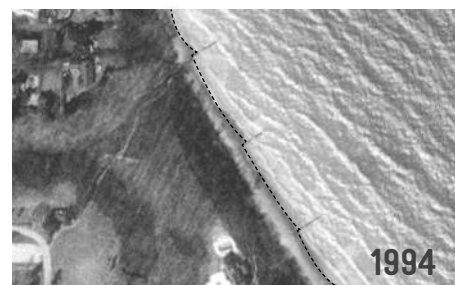
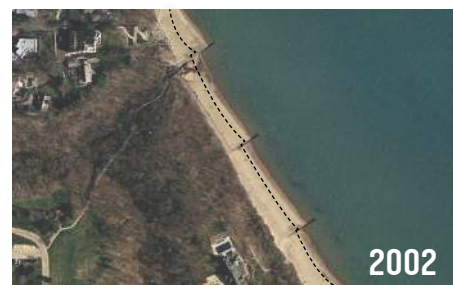
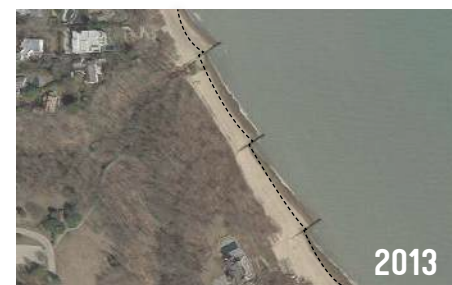
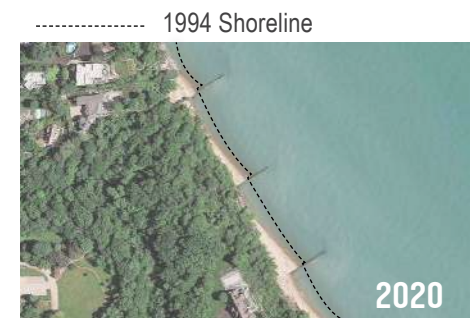
Figure 2.9 Existing Conditions at Moraine Beach

the sandy interface have fallen or are pitched toward the lake making walking on the beach during high water impossible without entering the water. Cutting of the bluff toe and removal of this soft sediment is an indication of future bluff instability issues even after lake levels recede.

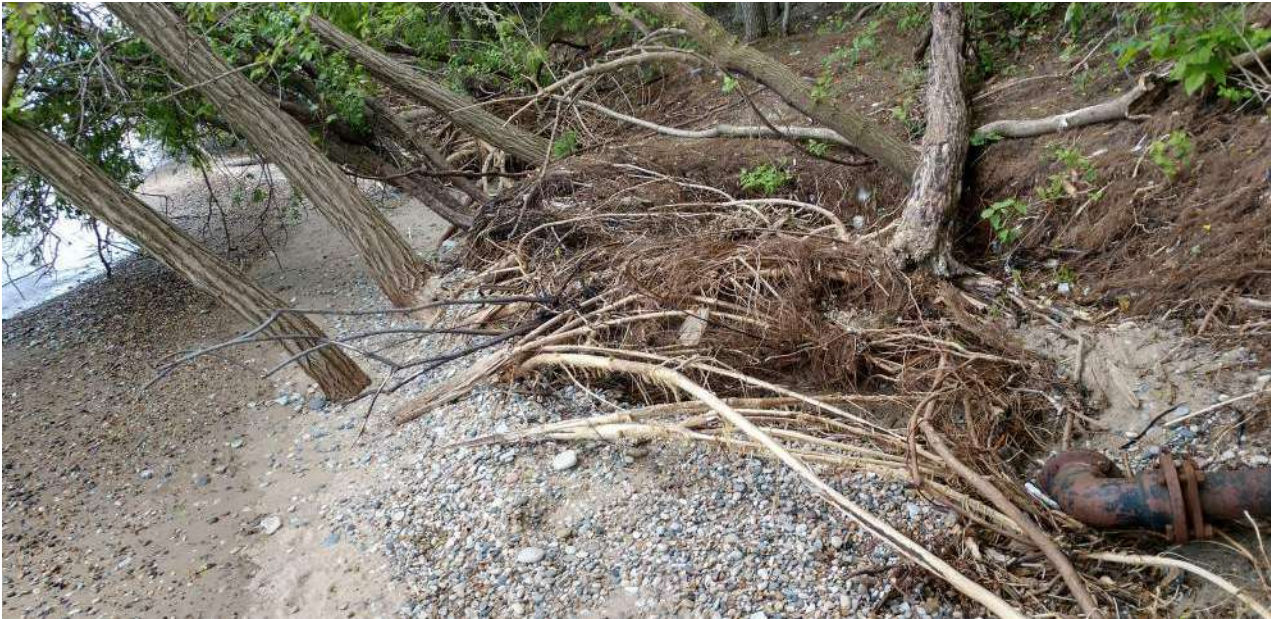
Figure 2.10 Root Exposure Caused by Wave Action Along the Bluff Toe

However, as referenced, the toe of the bluff is experiencing a direct wave attack due to high water levels. This has led to erosion of the toe and around the tree roots which may lead to overall bluff instability. This will not self-repair once lake levels recede.

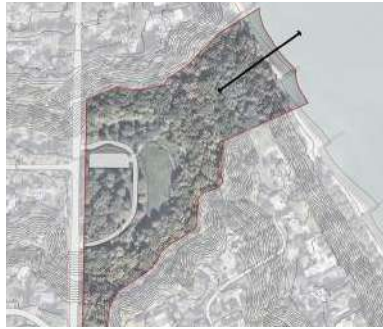
Figure 2.11 Cross Section of Moraine Beach

- 10% Annual Chance 582.6
- 4% Annual Chance 582.9
- 2% Annual Chance 583.0
- 1% Annual Chance 583.2
- 0.2% Annual Chance 583.3
- 1% Annual Chance Total Water Elevation 586.8

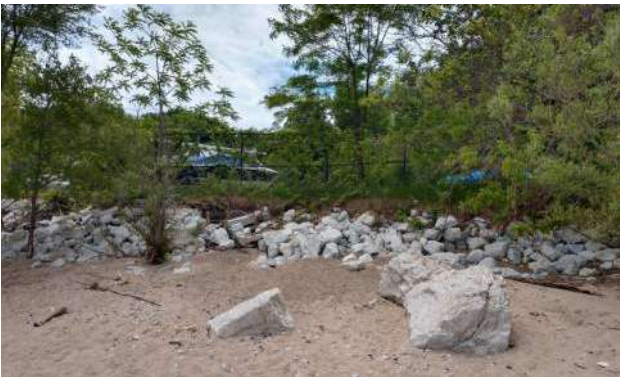
Figure 2.15 Remnant revetment stones on the north beach

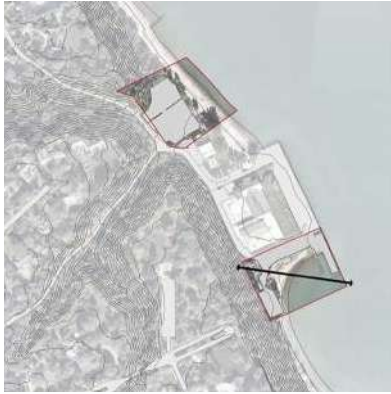
Figure 2.17 Cross Section of South Beach at Park Ave Boating Facility

10% Annual Chance	582.6
4% Annual Chance	582.9
2% Annual Chance	583.0
1% Annual Chance	583.2
0.2% Annual Chance	583.3
1% Annual Chance Total Water Elevation 586.8 North Beach	
1% Annual Chance Total Water Elevation 587.6 South Beach, Boating Facility

further inshore. This effect will be stronger on the southern side of the property, and south of the NSYC parking pad. Without protection, the southern end of the parking pad will erode significantly, subjected to direct wave attack. While the beach area in front of the NSYC will become inundated, the still waterline at historic highest water level will not reach the building itself. However, wave runup in high water scenarios may still reach the foundation.

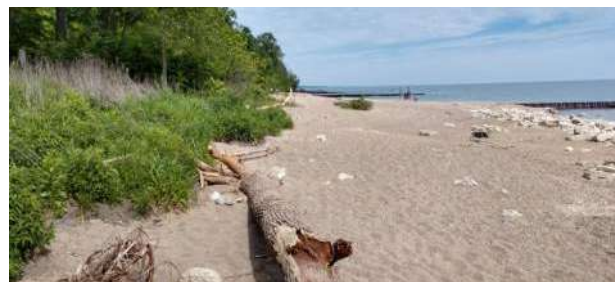
The northern beach is wider with fewer trees in the upper to middle beach portions furthest from the lake edge. The vegetation consists of low brush and dune grasses fronting larger trees located at the toe and on the slope of the bluff. (Fig 3.21 and 3.22). With the winnowing of the beach in the northern reaches of the property, this vegetation has been uprooted resulting in die-back and trees pulling away from the slope. This will further exacerbate bluff erosion.

Figure 2.21 Millard Beach viewing North

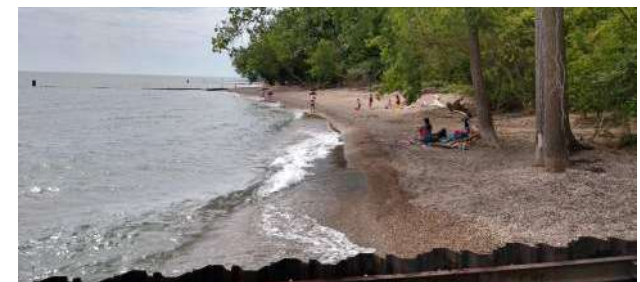
Figure 2.22 Millard Beach Viewing South

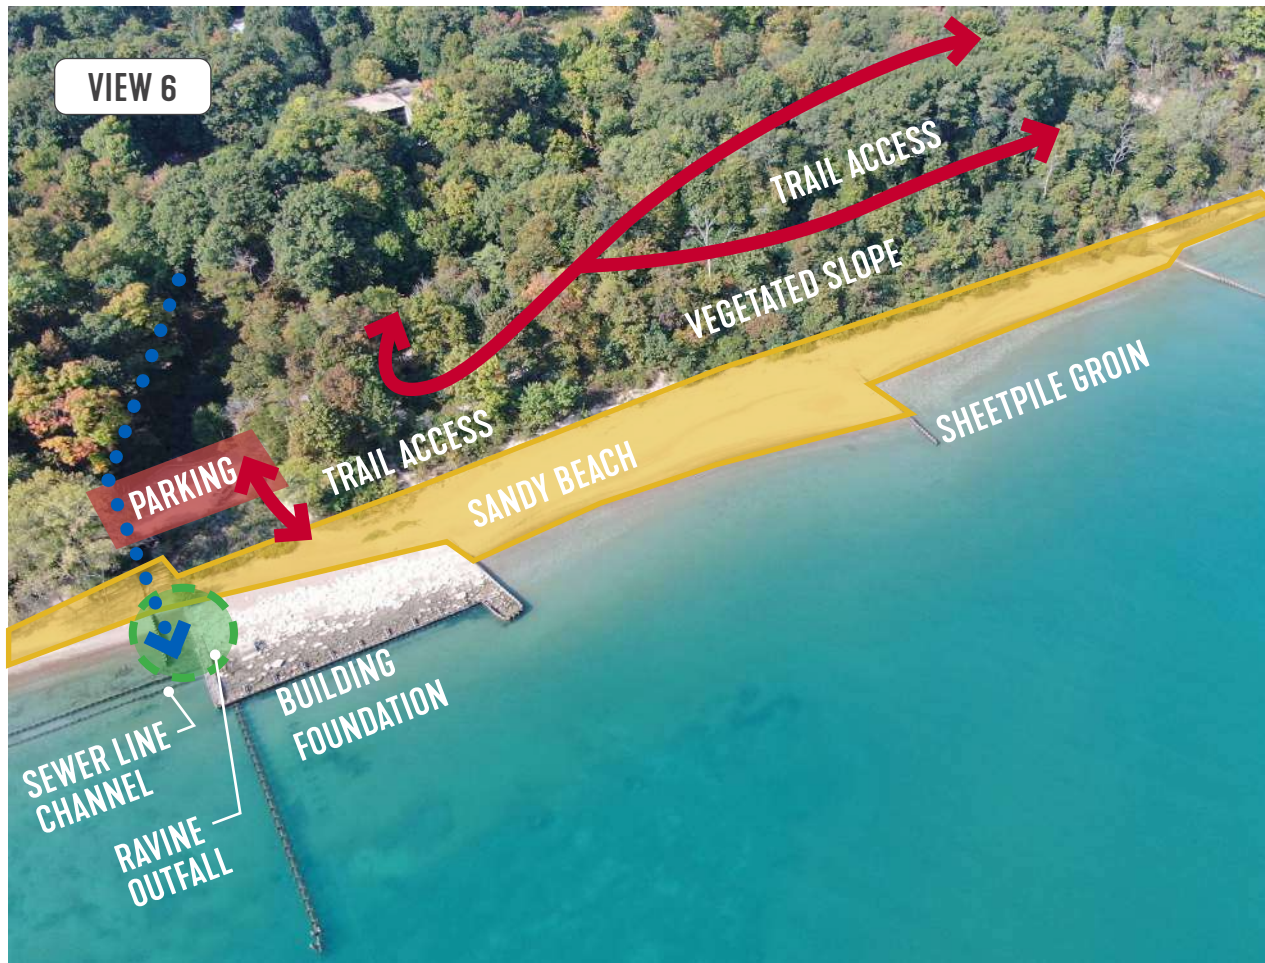
Figure 2.23 2020 Aerial Photo of Millard Beach, South

The high-water levels of 2019 & 2020 resulted in segments of bluff failure between the first and fourth groin. The compromised toe exhibits an almost vertical face which is inherently unstable. Vegetation roots are fully exposed in some areas. While the primary cause of the bluff failure was wave attack at the toe and ground saturation, the dense tree canopy cover and open soft sediments contributed to the failure. Bluff face vegetation will continue to pull on the topsoil layer exposing the soft sediments below. The combination of weakening of vegetation roots as the plant withers and stormwater cutting into the soft soils will lead to a full bluff face collapse as the slope attempts to correct itself back to a stable position. This can happen immediately or may take years but without intervention, the current slope will break and slump.

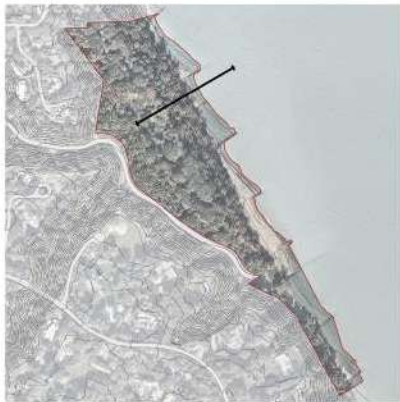
Figure 2.25 Cross Section of Millard Beach

The height of runup and influence of waves at the beach is estimated to be 587.9. Given the toe of bluff is located at roughly the 587 contour, this puts much of the bluff in jeopardy of toe erosion. Review of the 2017 survey shows areas where the toe of bluff starts at the 585 contour. Not coincidentally, these areas are where bluff toe failure can be seen in 2020 aerials.

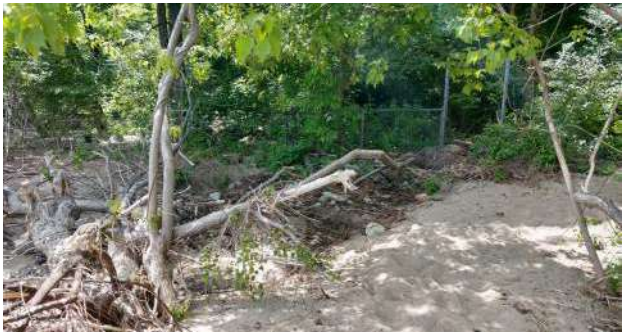
line remains beneath the water surface and no damage has been reported by maintenance staff. However, it may be beneficial to place coarser sand fill inside the channel to limit future exposure. As the walls of the channel are made from sheetpile, human interaction is a safety concern.

Figure 2.26 Residential discharge channel across beach.

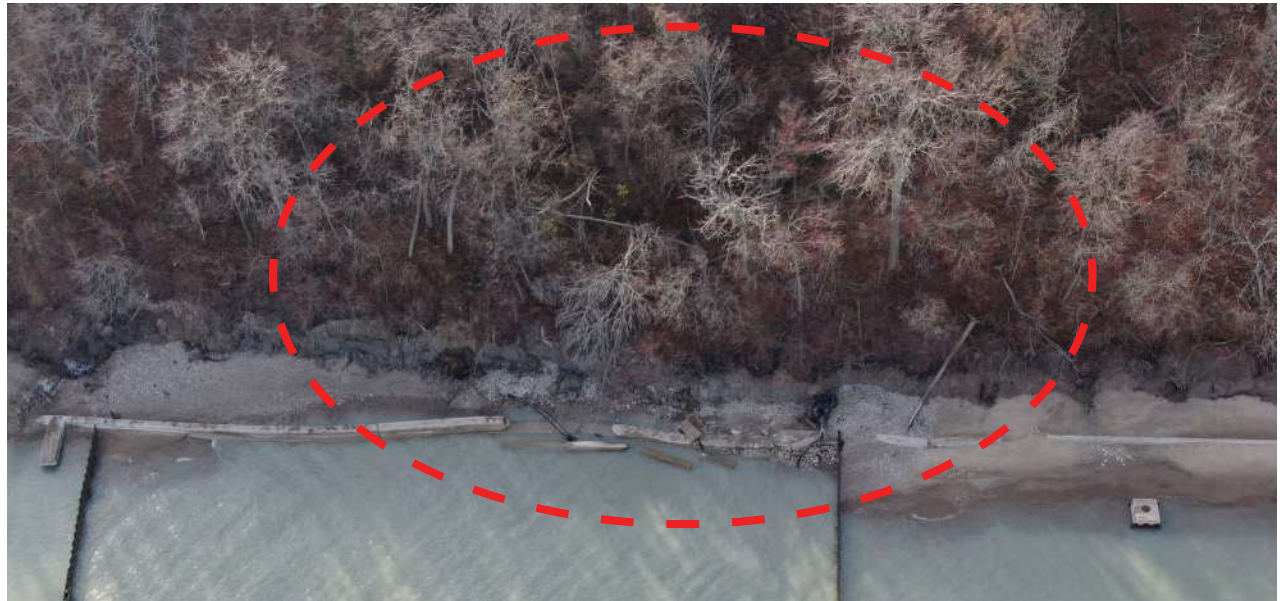
Figure 2.27 Aerial Photo of Bluff Failure, Late Fall 2020.

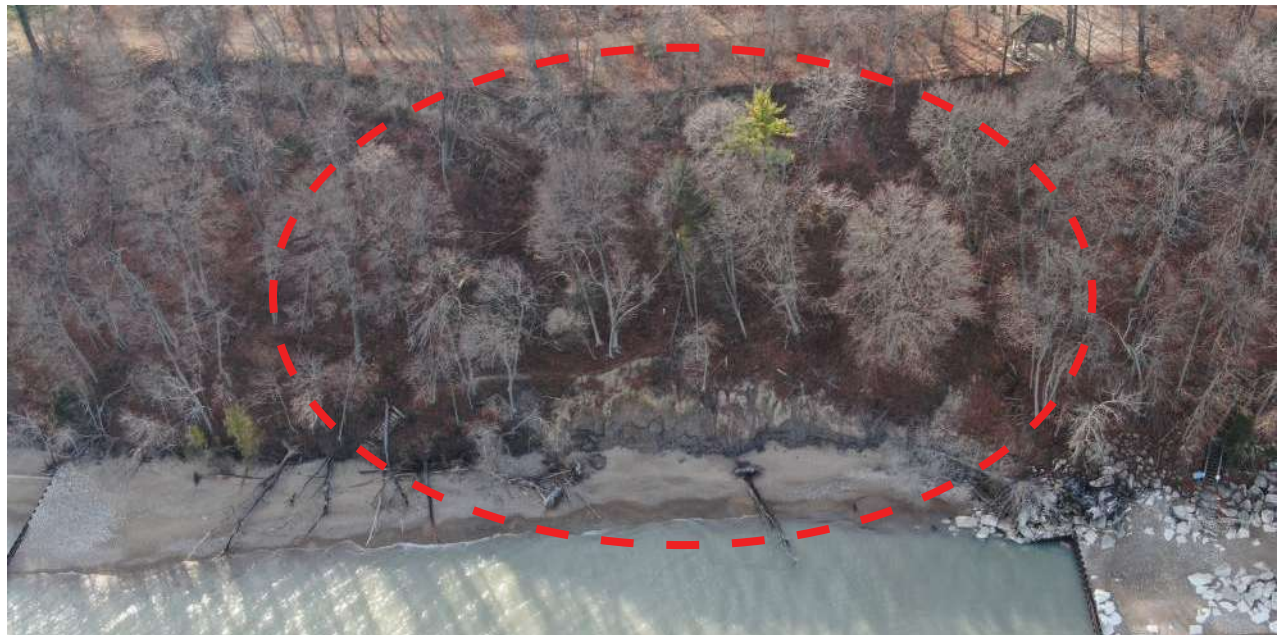
Figure 2.28 Aerial Photo of Bluff Subsidence, Late Fall 2020.

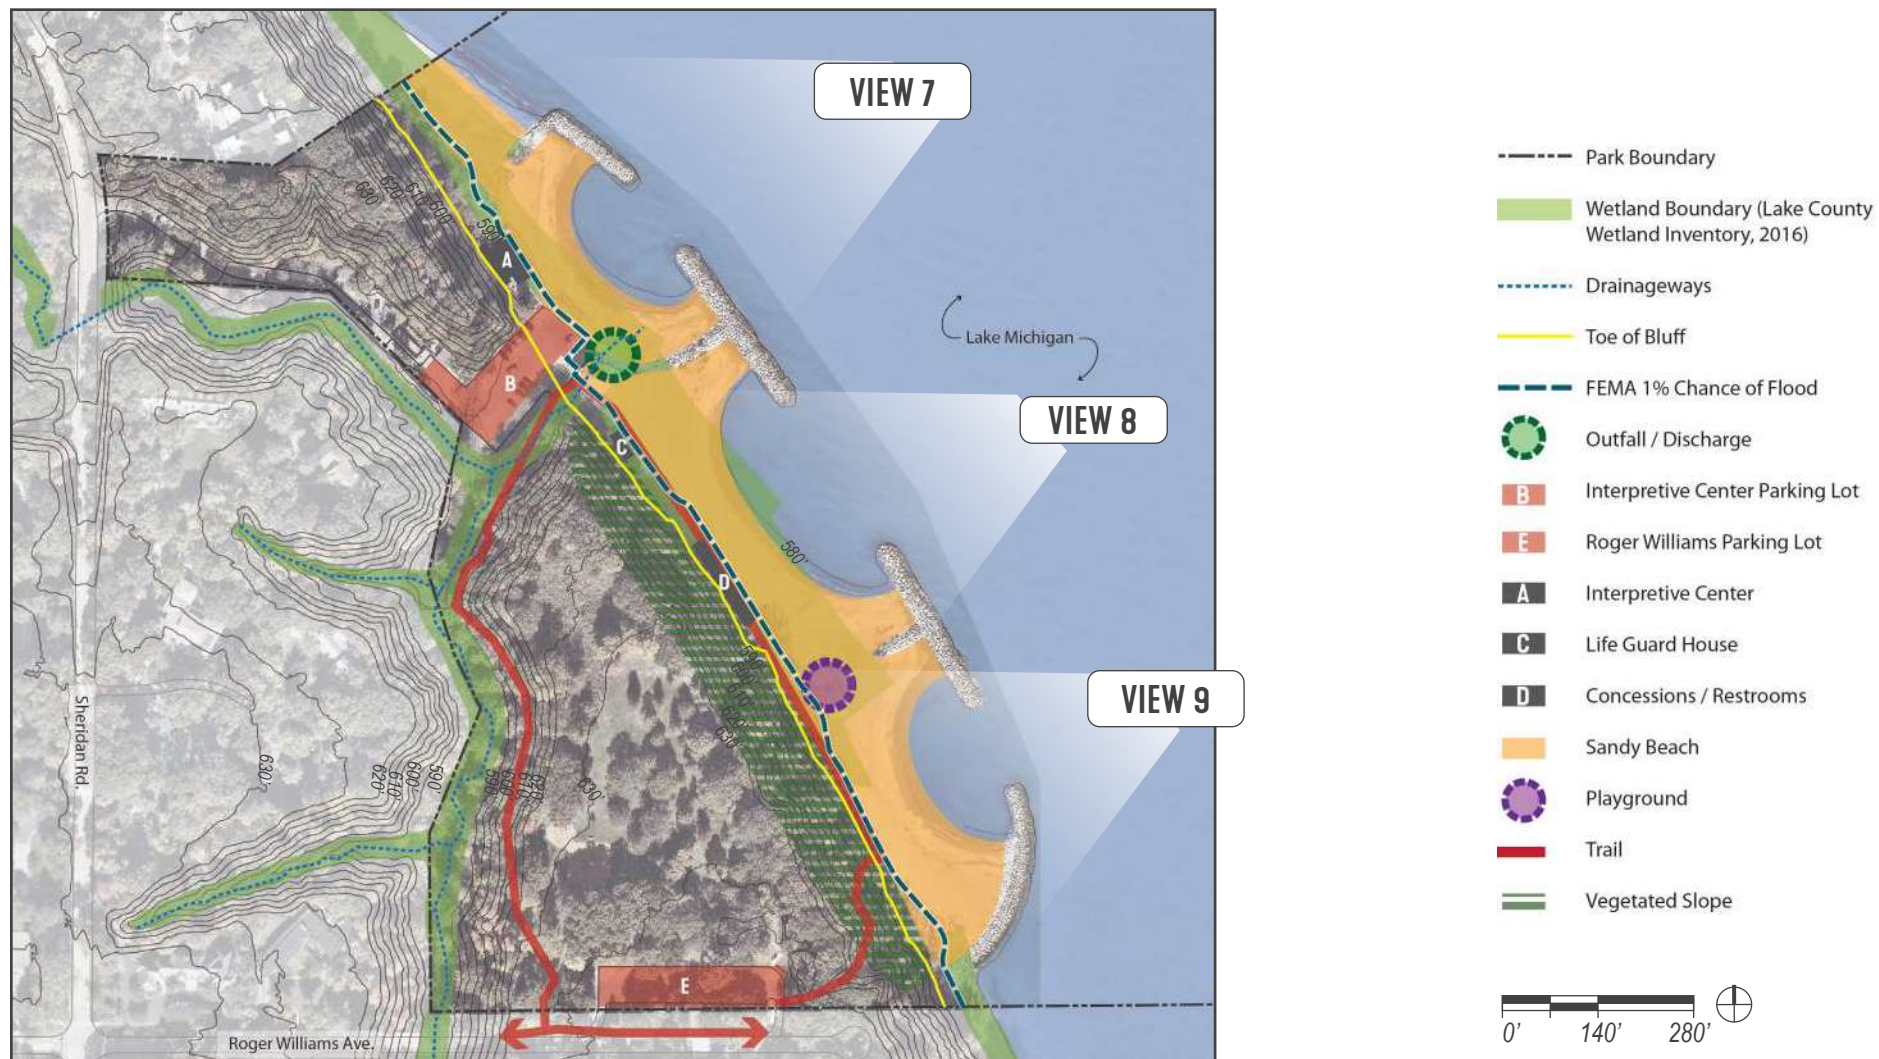
Figure 2.33 Existing Conditions at Rosewood Beach

Areas west of the bridge, over the ravine creek discharge, have been damaged by storm surges.

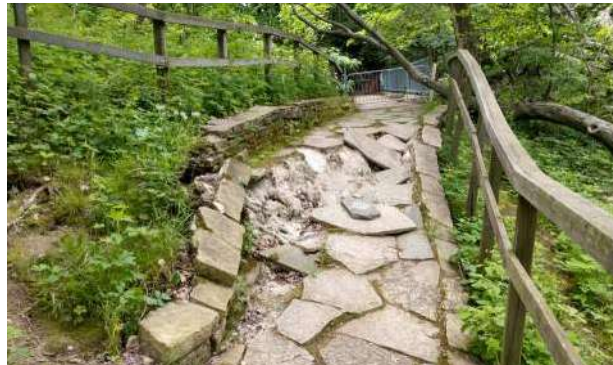
Finally, the existing wooden stairs from the top of bluff in Moraine Beach to ravine bridge crossing should be replaced. During the site inspection of this beach the stairs were found to be mushy, split, and face rotting in places.

Figure 4.1 Collapsed trail to Moraine beach

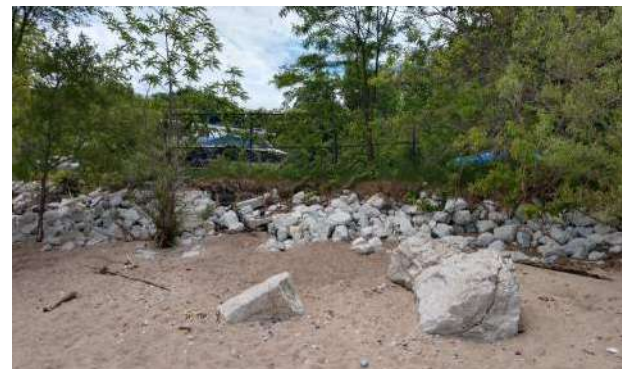
Figure 4.2 Remnant revetement stones on the north beach

The parking lot at the North Shore Yacht Club needs to be restored and protected. Depending on the type of scour protection developed permitting will be required. An evaluation of the expected permitting should be prepared as part of the design for the scour protection.
