MILLARD BLUFF SLOPE STABILITY ANALYSIS

MILLARD PARK

Highland Park Lake County, Illinois

July 2, 2021

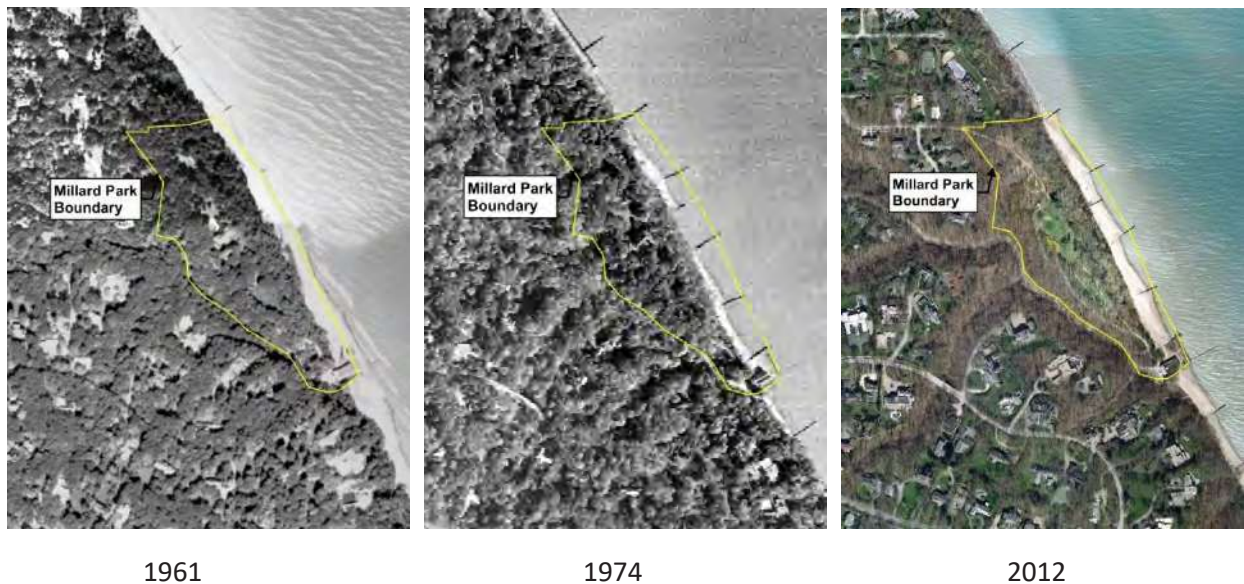
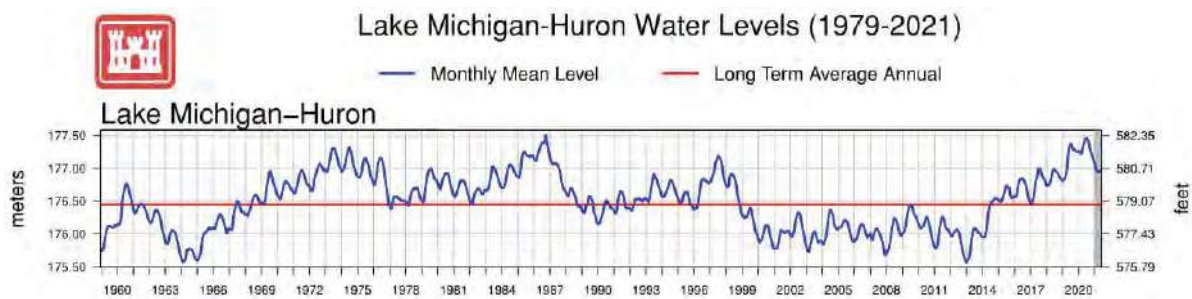
The historical photographs do a good job of showing the variation in lake levels over the years. Notably the aerial photographs from 1961 and 2012 when lake levels were headed towards historic lows as well as 1974 when the lake was near historic highs. These aerial photos, as well as **Figure 1.11**, given on the following page, help show the natural and fluctuating cycle of Lake Michigan water levels.

Figure 1.11 Historical Aerial Photographs with Corresponding Water Level Elevations.

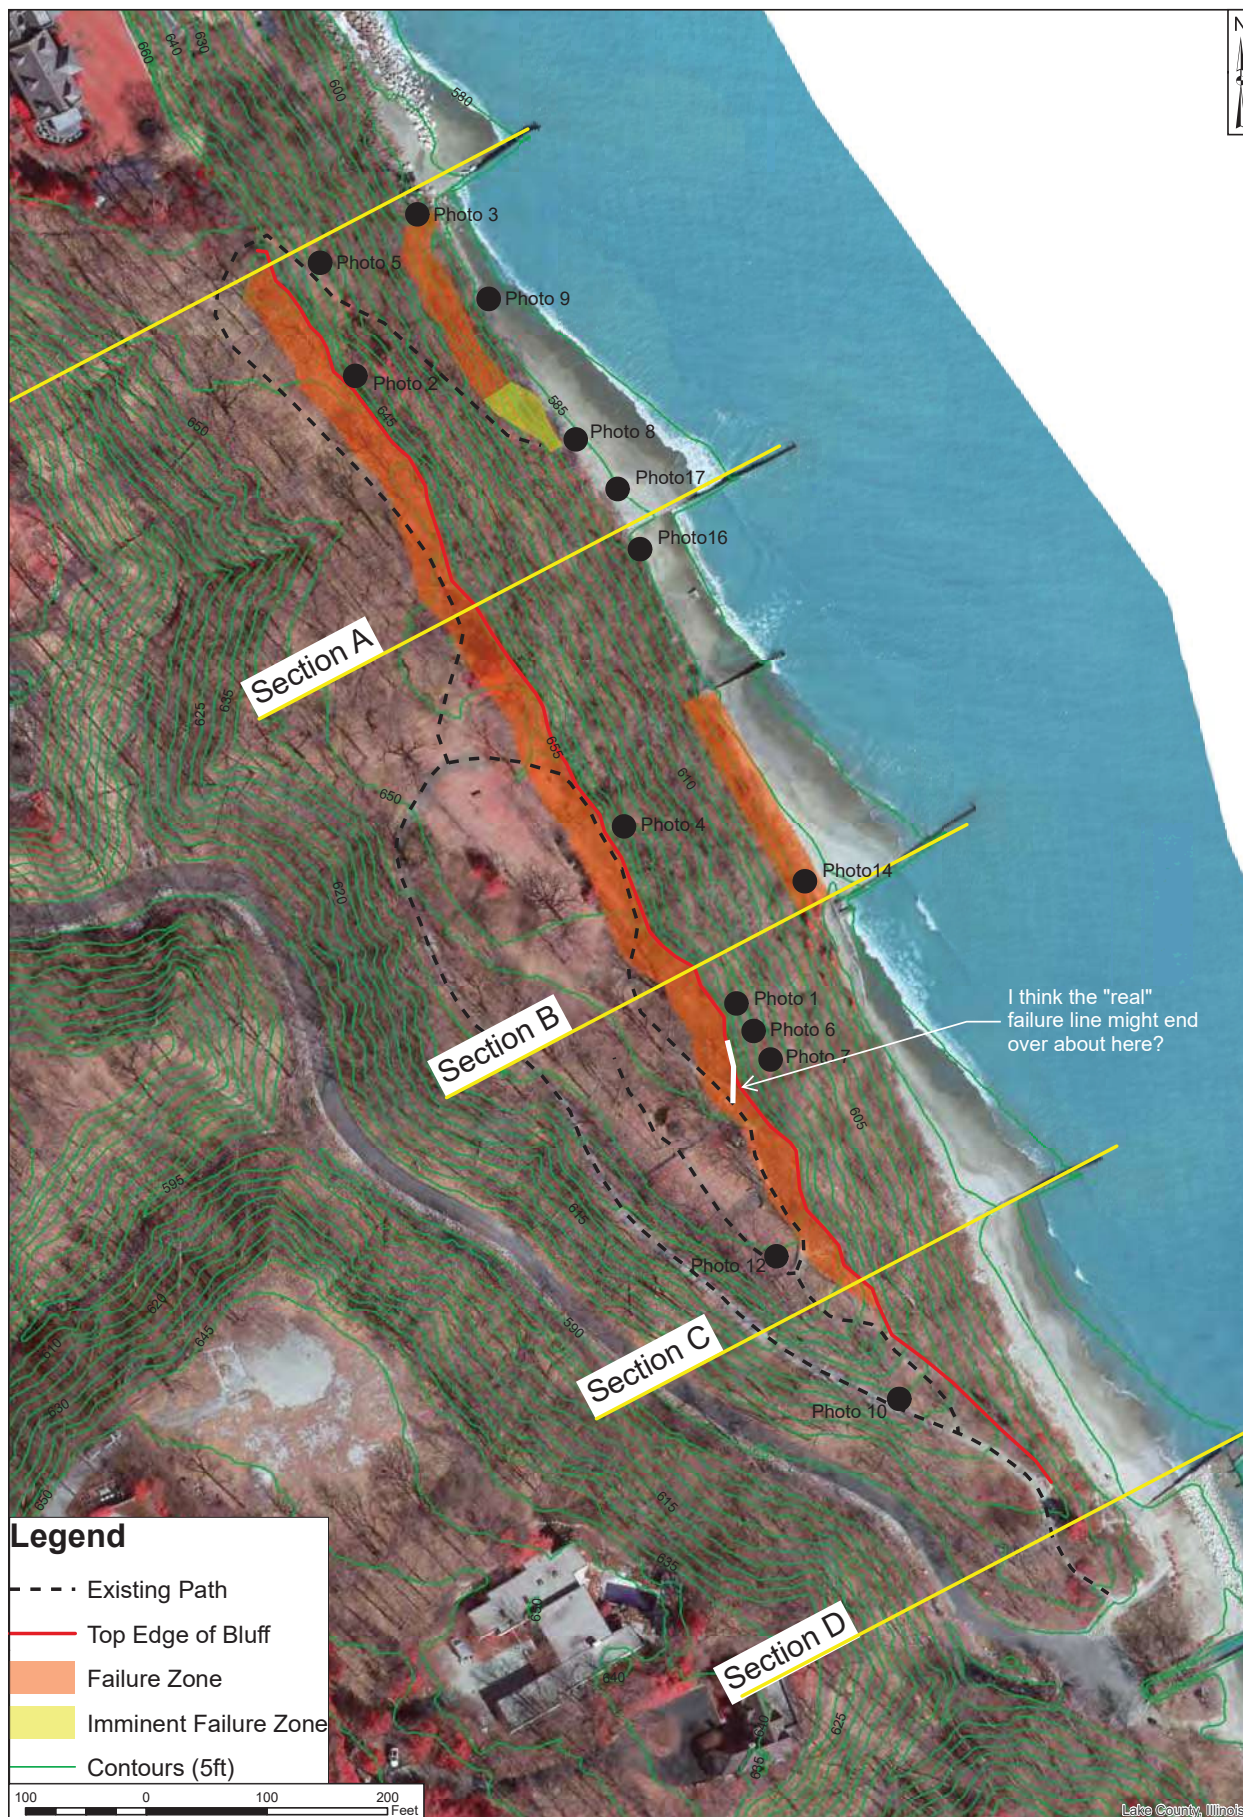
- - - Existing Path
- Top Edge of Bluff
- Failure Zone
- Imminent Failure Zone
- Contours (5ft)

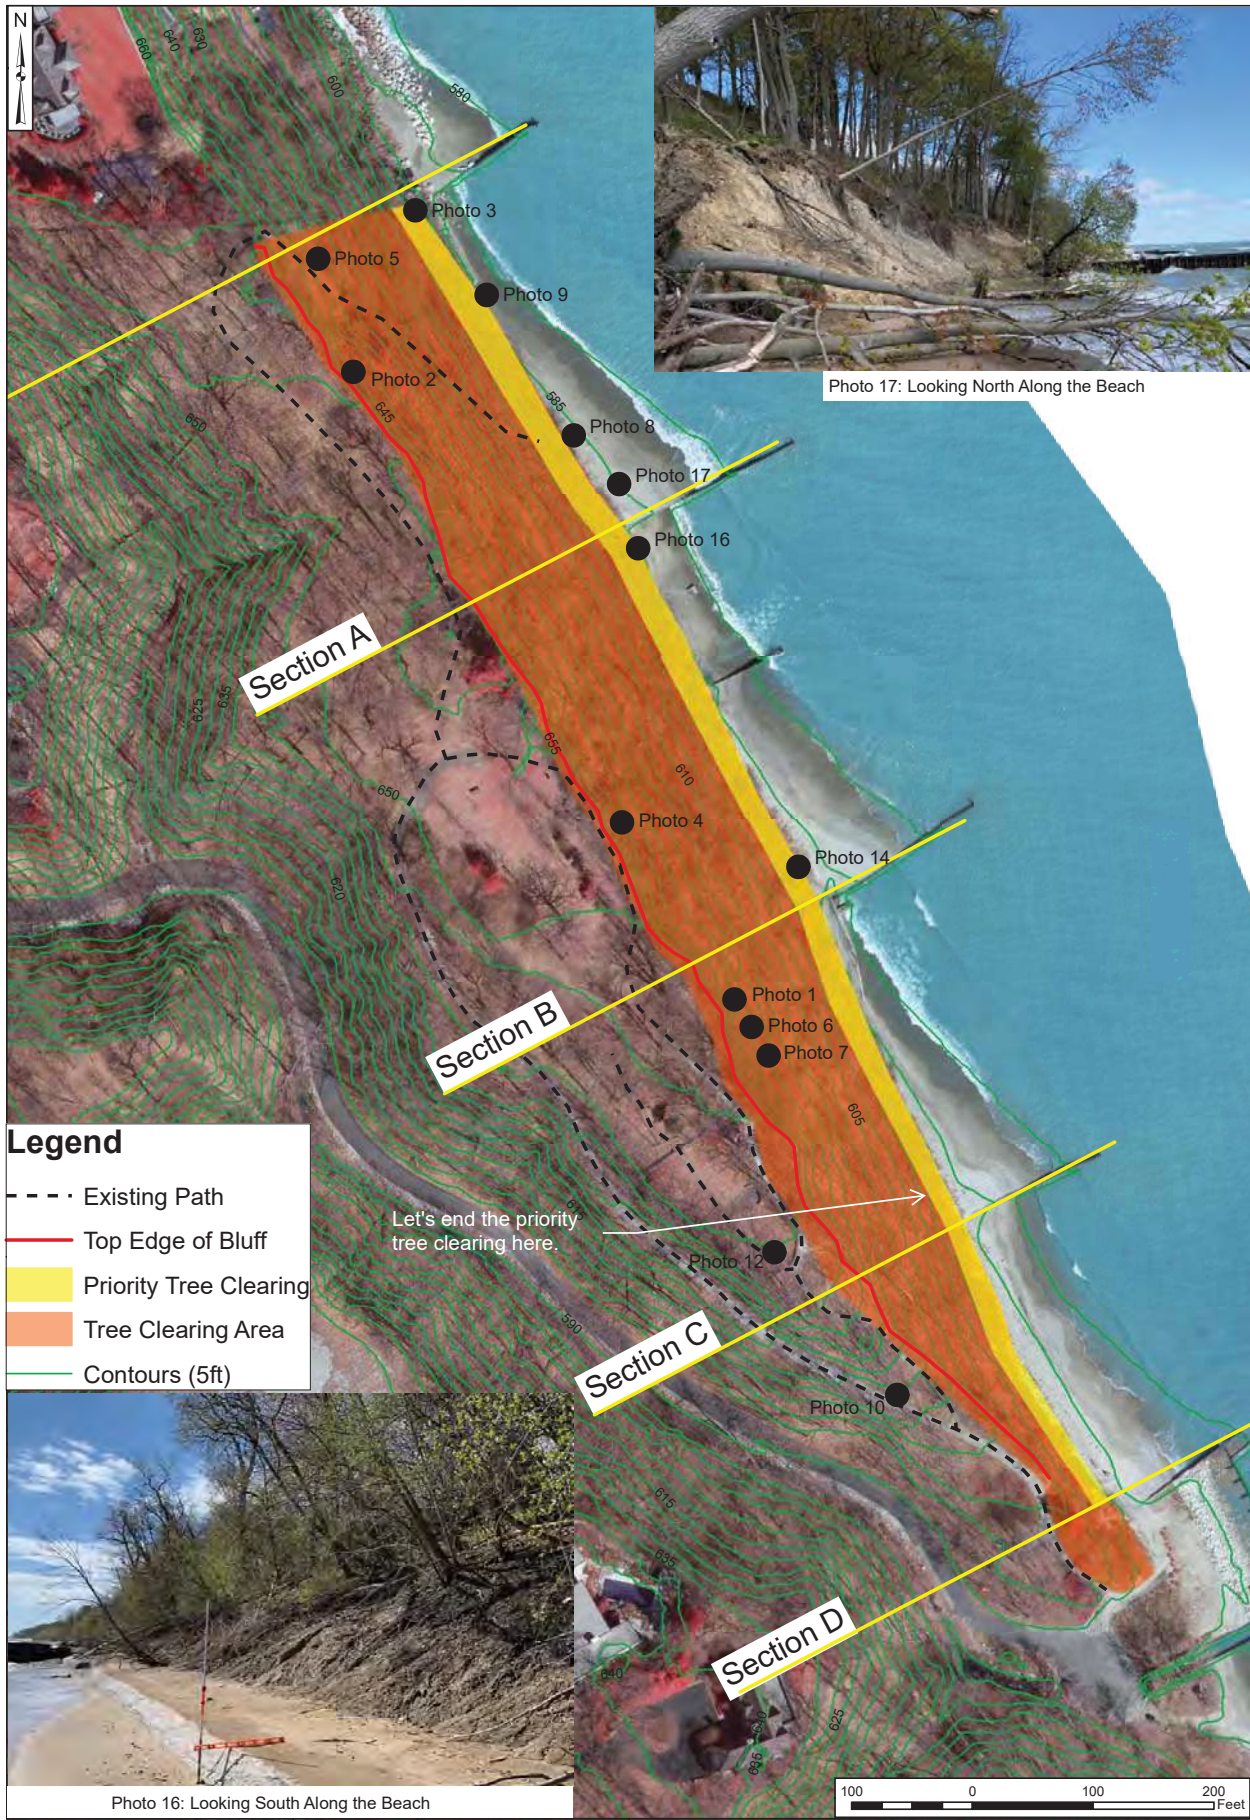
- Existing Path
- Top Edge of Bluff
- Yellow Priority Tree Clearing
- Orange Tree Clearing Area
- Green Contours (5ft)

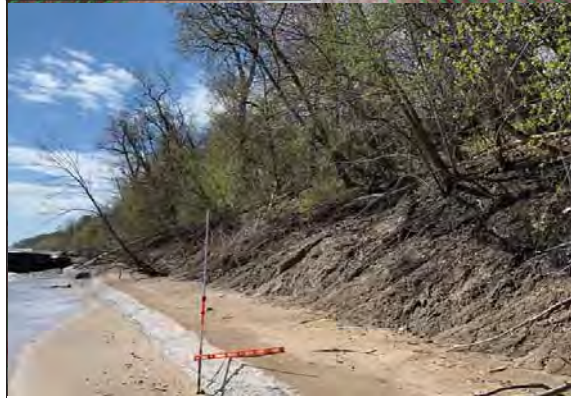
Picture 16: Priority Tree Removal area on north end of Section B looking south.

Photo 16: Looking South Along the Beach

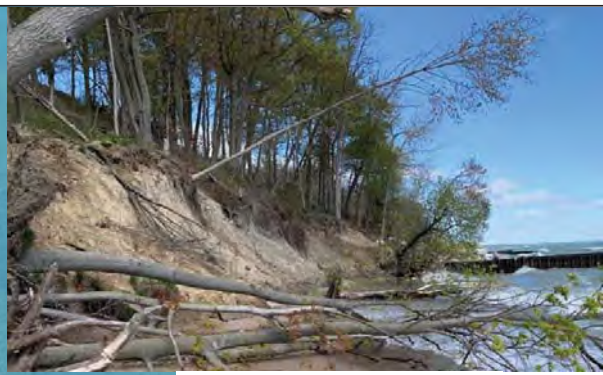
Picture 17: Priority Tree Removal area on south end of Section A looking north.

Photo 17: Looking North Along the Beach
